# OLD GUNDAGAI GAOL MASTERPLAN REPORT

30 JULY 2018

OLD GUNDAGAI GAOL MASTERPLAN REPORT

### APPENDIX 2 - ARCHAEOLOGY ASSESSMENT REPORT

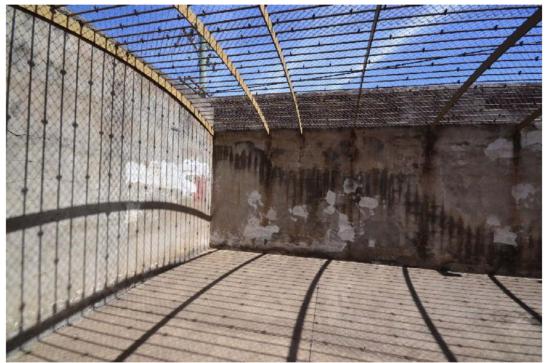
The exercise yard with intact high walls is a vine example of a structure that provides evidence of the historical use of the gaol as a place of prisoner confinement.

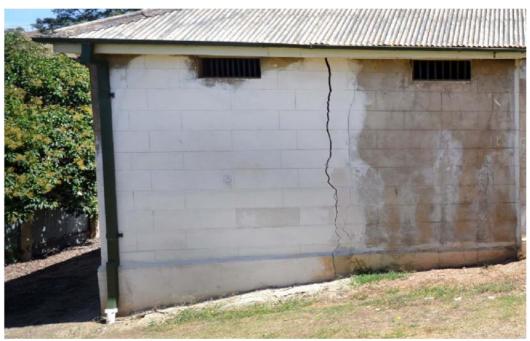
A large crack has appeared on the rear wall of the cell block. This has probably been caused by settlement of the downslope corner of the building.

Detail of settlement of corner of cell block wall. The proposal is to underpin in Uretek method, close the crack and repair it by stitching. Archaeological monitoring is recommended.

The footings should be underpinned and stabilised. The Uretek method is the most economical and is also recommended for lifting the building to close the crack.

The wall crack should then be repaired by "stitching" (cutting channels out of the wall and cementing in threaded stainless steel bars). The engineer's or architect's detail should be followed.

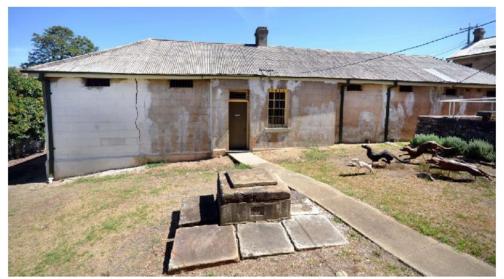
A previous attempt was made to lime wash the rear wall of the cell block. This finish failed and was removed by pressure cleaning.

Attempts to lime wash and to remove lime wash have failed and should be replaced with a Murabond paint, specially made for this kind of application.

Older layers of limewash have been examined during inspection. Two colours were found. The light colour approximates "Murobond Clay". The darker of the two colours approximates "Murobond Hawkesbury". The darker colour is recommended for a limewash type finish as it will be lower maintenance than light colours.

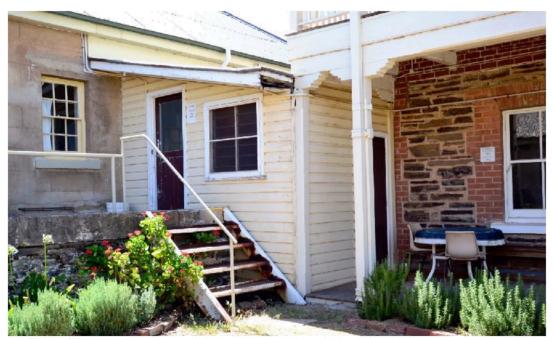
The former covered passage has been walled in. This has trapped roof water, causing timbers to rot, damaging the adjoining residence and providing conditions for termite entry. The "low roof" warning sign is inadequate protection against visitor injury. Owner is still liable for having an entry that does not conform to the Building Code.

This infill is causing severe deterioration and should be reinstated to a covered way.

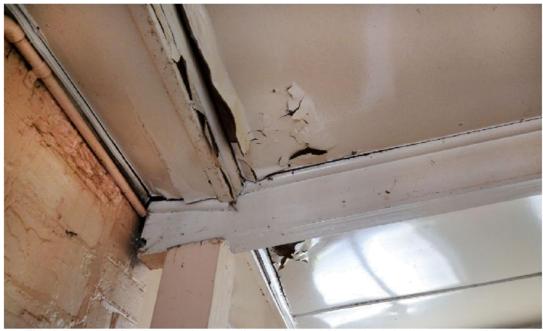
This infill is causing severe deterioration and should be reinstated to a covered way.

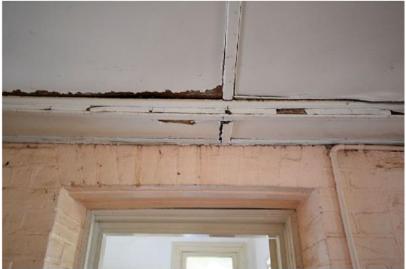
This infill is causing severe deterioration and should be reinstated to a covered way.

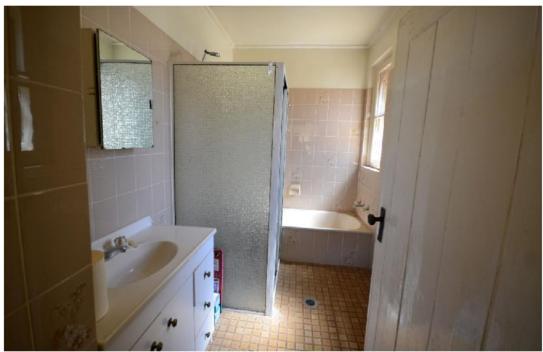
Existing bathroom area is the most suitable location on site for a disabled toilet conversion.

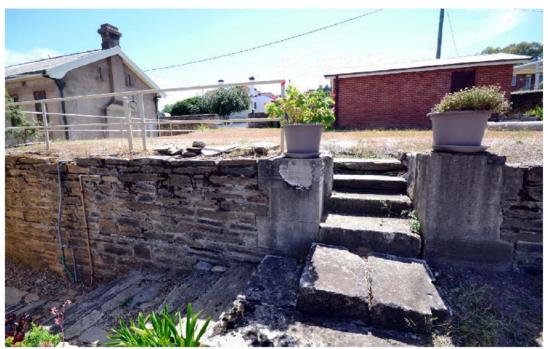
The last step to the top exercise yard indicates likely original yard level. This should be reinstated. The garden pots are irrelevant items and should be removed.

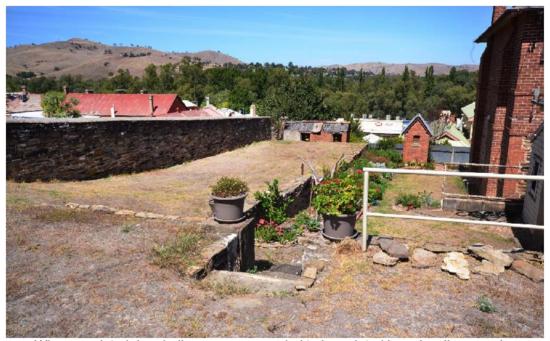
When repainted, handrails are recommended to be painted in a visually recessive gunmetal colour, not cream. They are a recent addition and do not need visual emphasis.

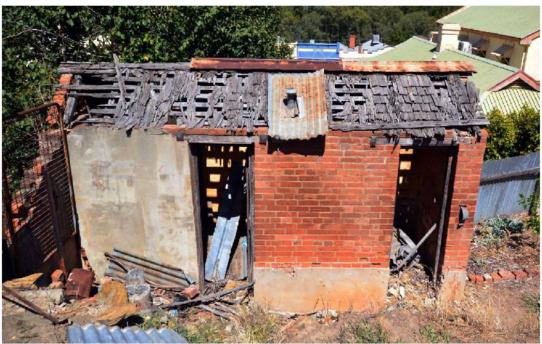
Double cubicle toilets should be reroofed in c.g.i. as specified.

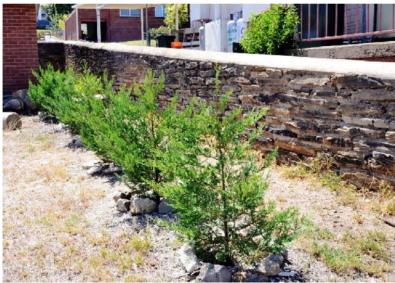
Planting to screen out views of the adjoining private residence has a useful function, but the species choice should be reviewed. Replanting in a limited height hedge species is recommended. In time, these conifers will destabilise the wall and cause significant expense to remove.

Remove the cypress hedge from the fence of the men's exercise yard. This appears to have been planted to screen out the adjoining house. But if allowed to grow it will damage the stone fence. An alternative, less vigorous hedge may be planted.

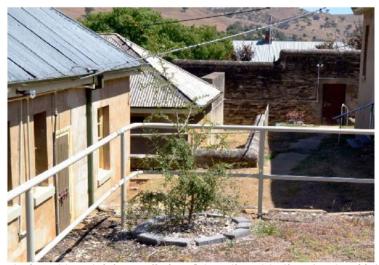
The tree planted next to retaining walls is a future threat to the structural integrity of the walls and causes historical confusion. Everything added to the yards should help to clarify the questions: Was this a prison? Or was this a picturesque garden?

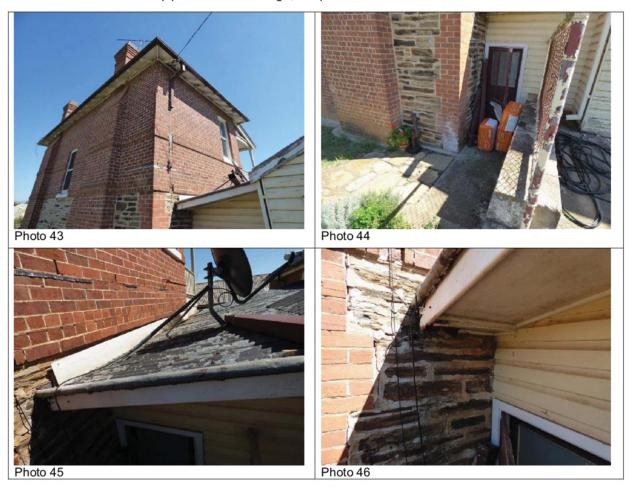
- Eastern corner of jailer's residence downpipe broken, see photo 43 and see photo at base photo 44.
- Box gutter along timber extension to kitchen, see photo 45.
- Disconnected downpipe and water damage, see photo 46.

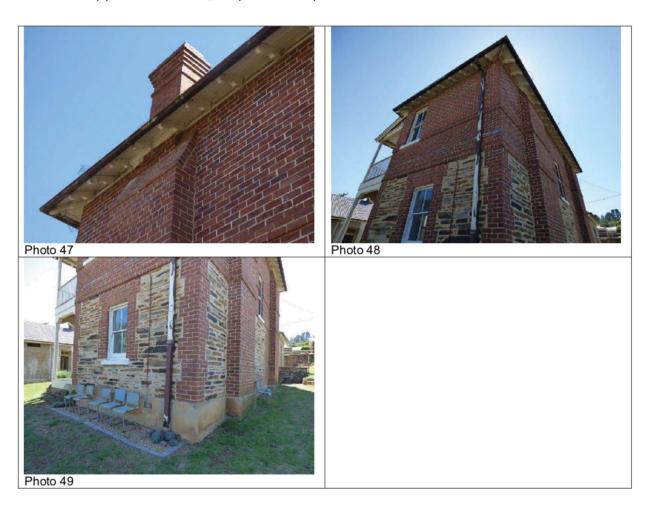
- Damage to gutter on jailer's residence, south eastern corner, see photo 47.
- Downpipe southern corner, see photo 48 and photo 49.

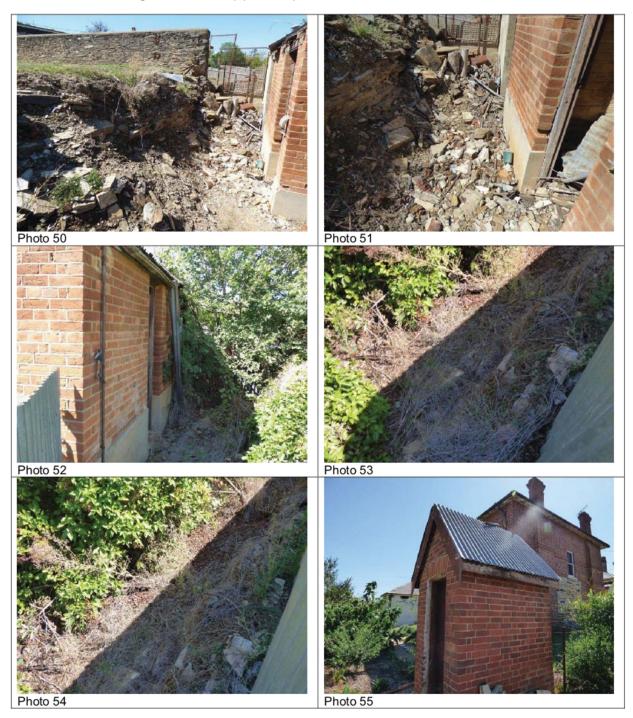
- Collapsing retaining wall at end of women's yard adjacent to toilet block, see photo 50.
- Low point formed in front of toilet block, see photo 51.
- Collapsed downpipe and gutters of toilet block, see photo 52.
- Courtside of fence leads to wall, see photo 53 and 54.
- toilet block, no gutters and downpipes, see photo 55.

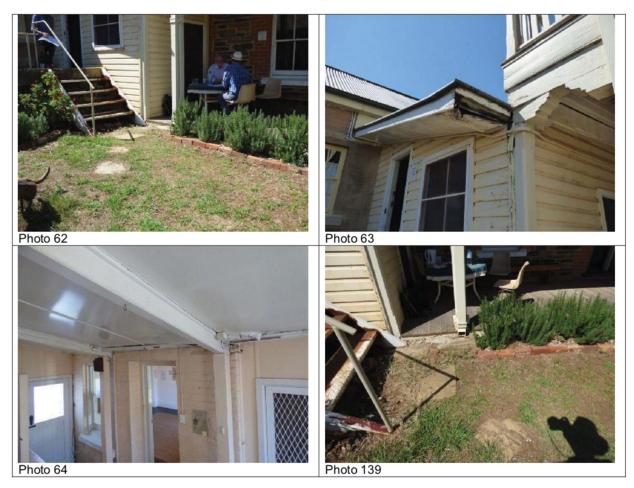
- Water damage to timber extension, see photo 63.
- Water damage to underside of timber extension between jailer's residence and kitchen, see photo 64.
- Down pipe with no formalized drainage see photo 139

**Summary:** The overland flow is working well in this area as it drains away from the existing buildings. The existing downpipes to be connected to proposed new storm water system.

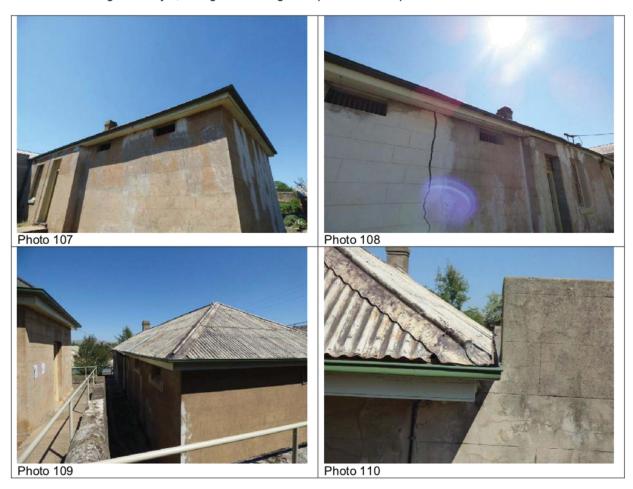
- Gutter damaged on jail, see photo 107 and photo 108.
- Photo of gutters of jail, noting uneven edge see photo 109 and photo 110.
