**COOTAMUNDRA-GUNDAGAI
REGIONAL COUNCIL**

COOTAMUNDRA FLOOD STUDY

FINAL

JANUARY 2021

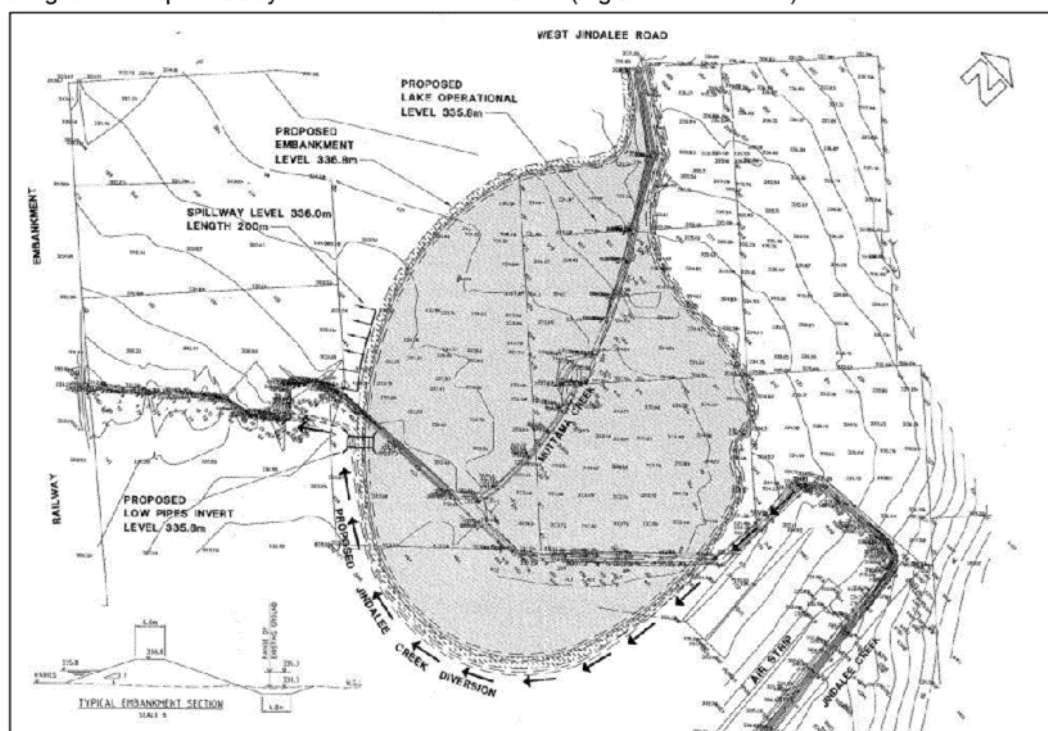
Diagram 1 Proposed Layout - Muttama Creek Lake (Fig B1 Reference 6)

The proposed lake layout is shown in Diagram 1. It is noted that at the time of writing, the lake and embankments had not been constructed.

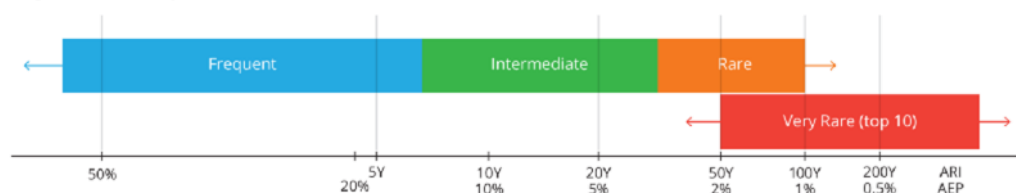
Diagram 2: Temporal Pattern Bins

The ARR 2019 method divides Australia into 12 temporal pattern regions, with the study catchment falling within the Murray-Darling Basin region. ARR 2019 provides 30 patterns for each duration, which are sub-divided into three temporal pattern bins based on the frequency of the events. Diagram 2 shows the three categories of bins (frequent, intermediate and rare) and corresponding AEP groups. The "very rare" bin is in the experimental stage and was not used in this flood study.

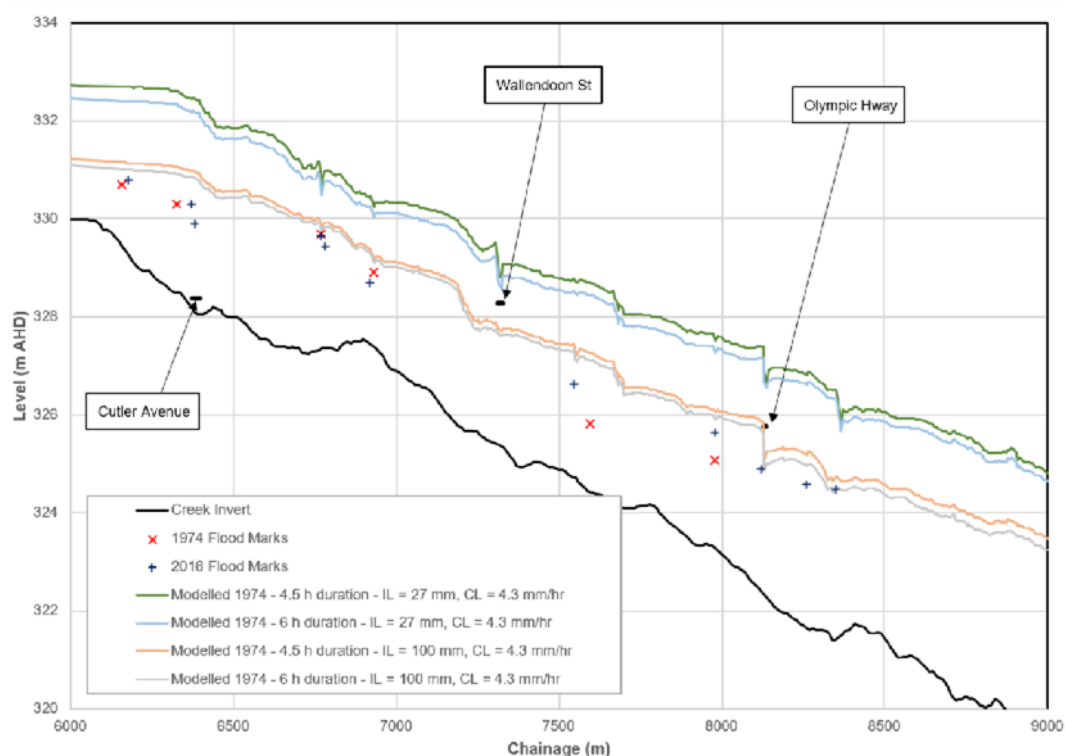
Diagram 3 Muttama Creek Long Section 1974 Event

The uncertainty associated with the available data for the 1974 event means that it cannot be used to directly inform hydrologic and hydraulic model parameters, however it is useful to confirm that broadly the hydrologic and hydraulic models can generally reproduce observed flood behaviour with reasonable assumptions in the selection of model parameters. In addition the assessment of the 1974 event has confirmed that a continuing loss of 4.3mm/hr is reasonable for the catchment.

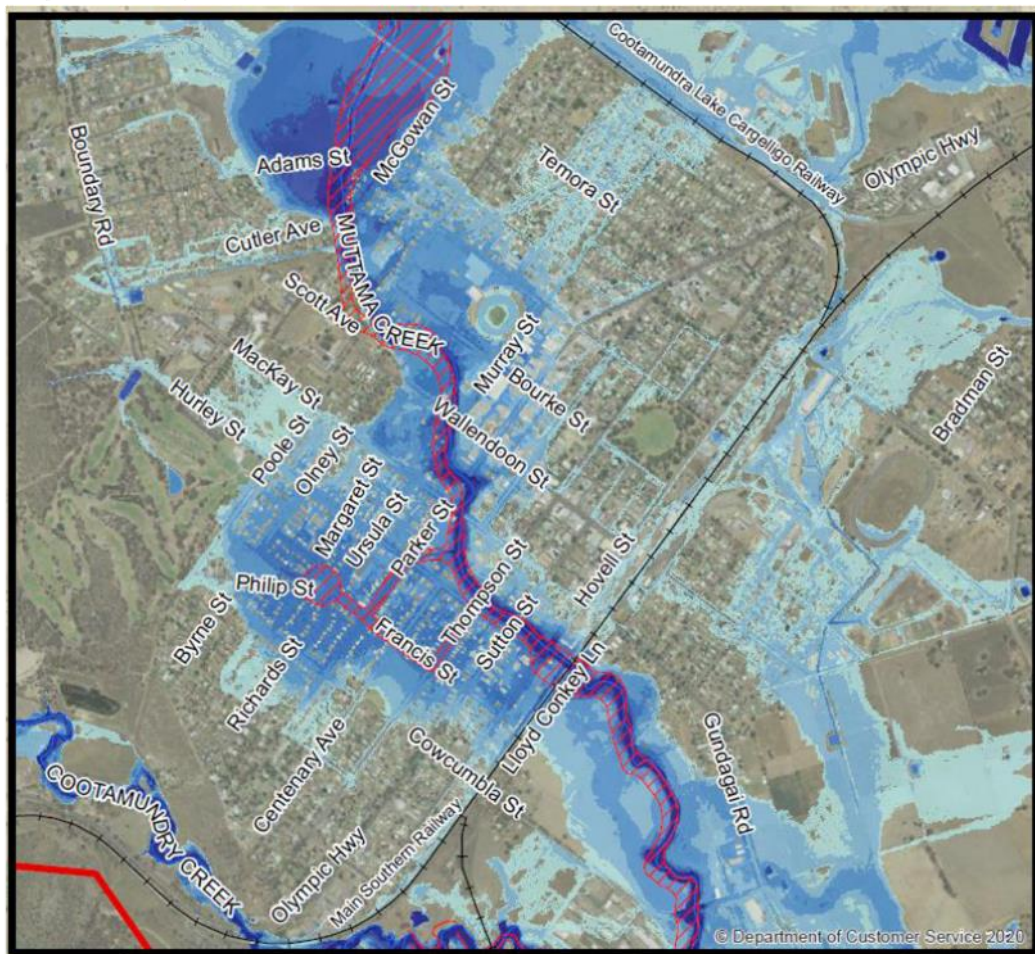
Diagram 4: Comparison of 1% AEP Flood Extent

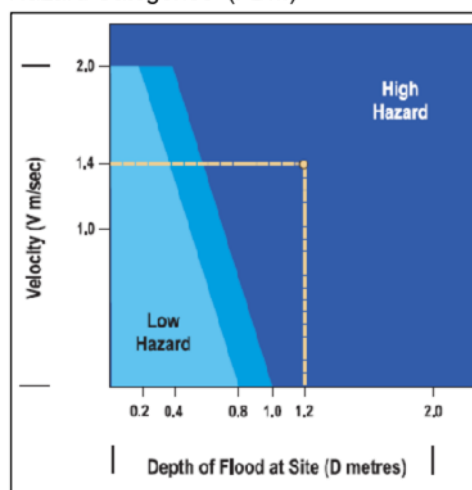
Diagram 5: "L2" Hydraulic Hazard Categories (FDM)

Appendix L of the NSW Floodplain Development Manual (FDM, Reference 2) gives one method for hydraulic hazard, which is shown in Diagram 5. In this study, the transition zone was considered to be high hazard.

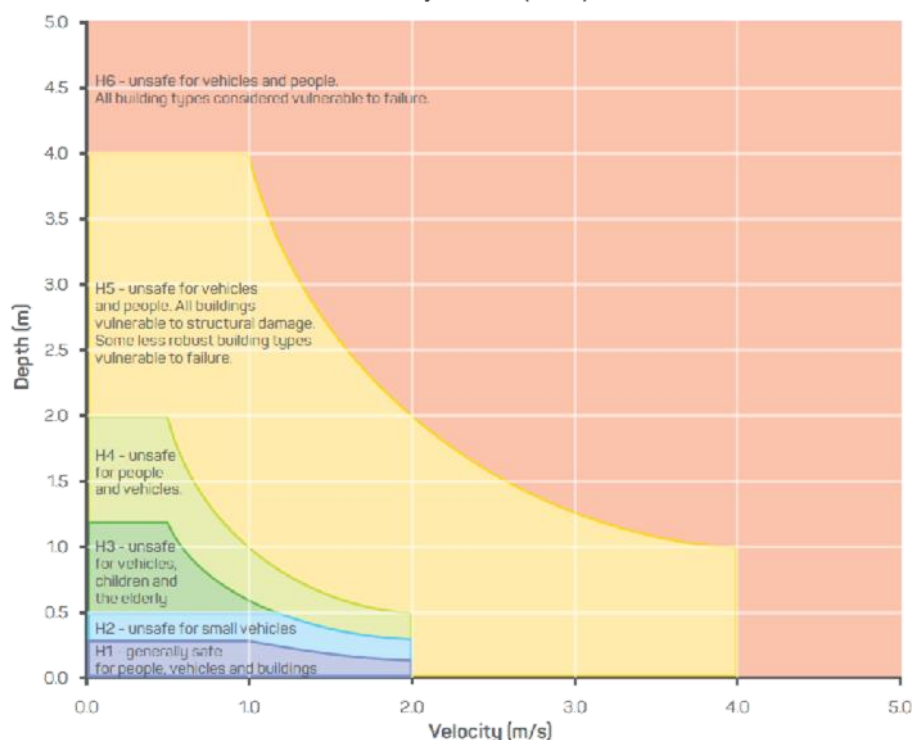
Diagram 6: General flood hazard vulnerability curves (ADR)

The Australian Disaster Resilience Handbook Collection deals with floods in Handbook 7 (Managing the Floodplain: A Guide to Best Practice in Flood Risk Management in Australia). The supporting guideline 7-3 (Reference 24) contains information relating to the categorisation of flood hazard. A summary of this categorisation is provided in Diagram 6.

This classification provides a more detailed distinction and practical application of hazard categories, identifying the following 6 classes of hazard:

- H1 – No constraints, generally safe for vehicles, people and buildings;
- H2 – Unsafe for small vehicles;
- H3 – Unsafe for all vehicles, children and the elderly;
- H4 – Unsafe for all people and all vehicles;
- H5 – Unsafe for all people and all vehicles. All building types vulnerable to structural damage. Some less robust building types vulnerable to failure. Buildings require special engineering design and construction; and
- H6 – Unsafe for all people and all vehicles. All building types considered vulnerable to failure.

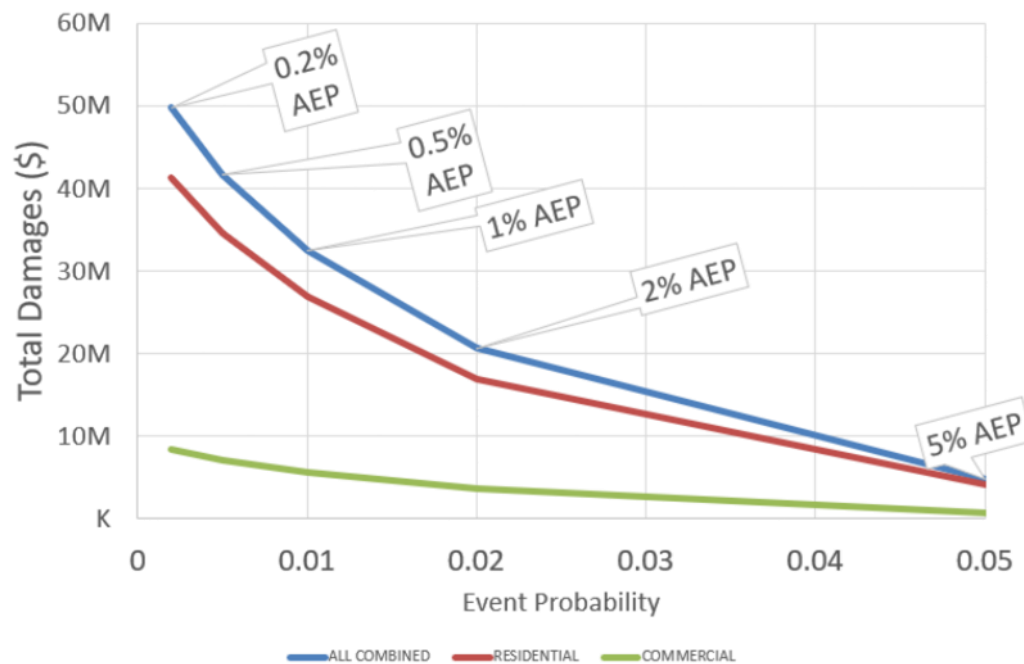
Chart 1 Total Flood Damages

Table 51: Estimated Total Flood Damages (residential & non-residential) for Cootamundra Catchment

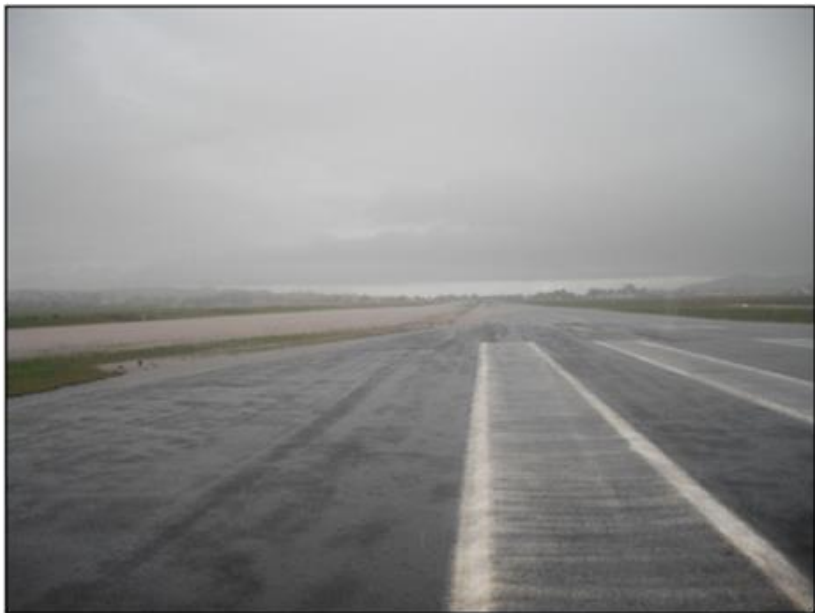
Cootamundra Aerodrome Runway

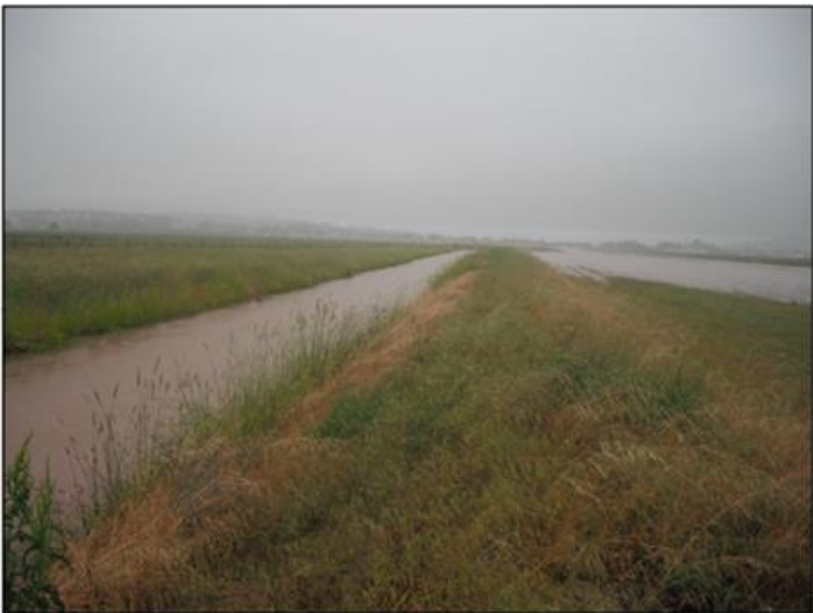
Swale along Aerodrome, looking South

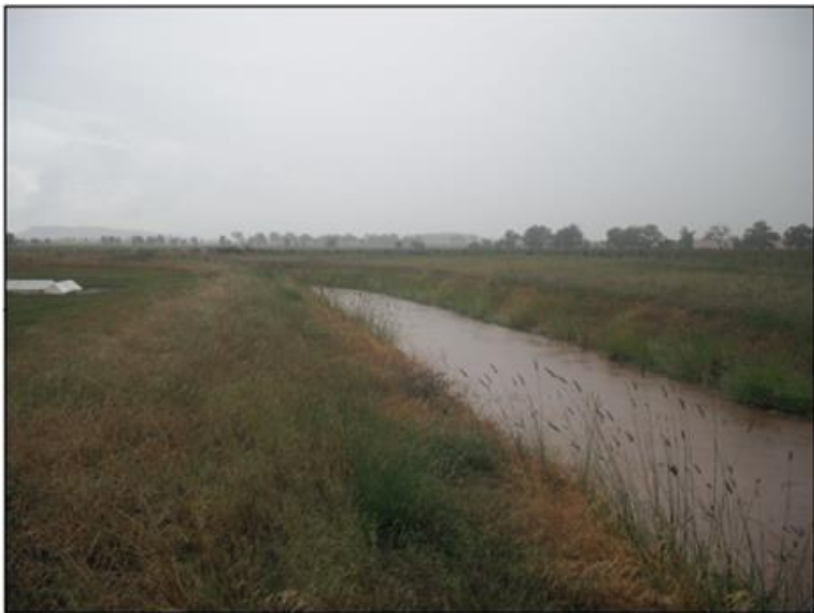
Swale along Aerodrome, looking North

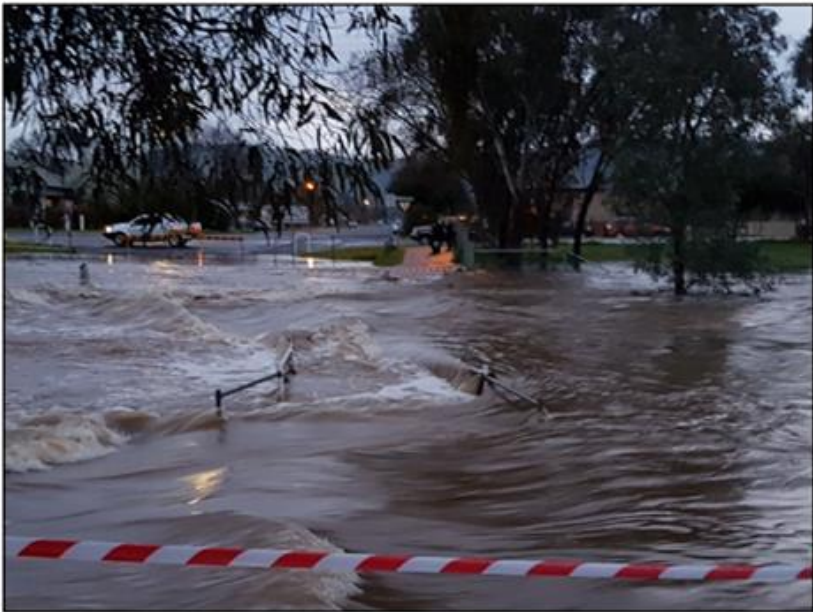
Footbridge, Thompson Street

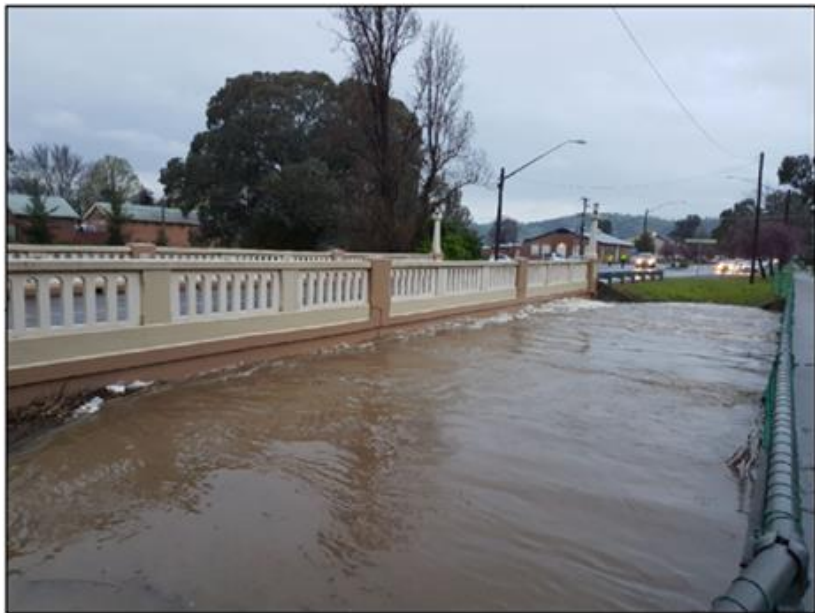
West Side of Parker Street Road Bridge

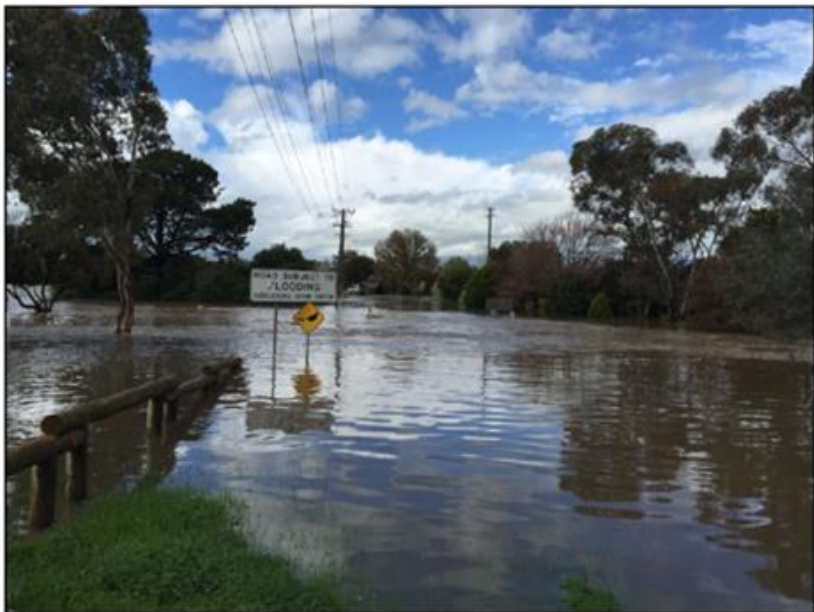
Hovell St Causeway (Photo: B.Cant)

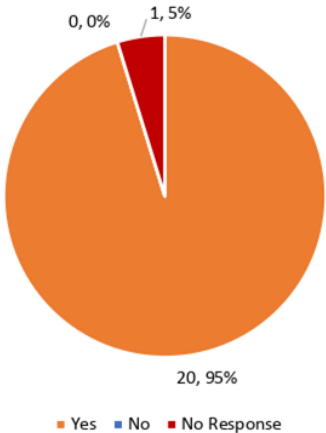
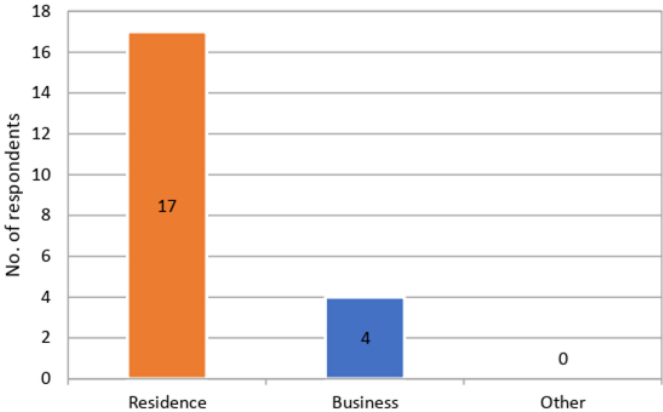
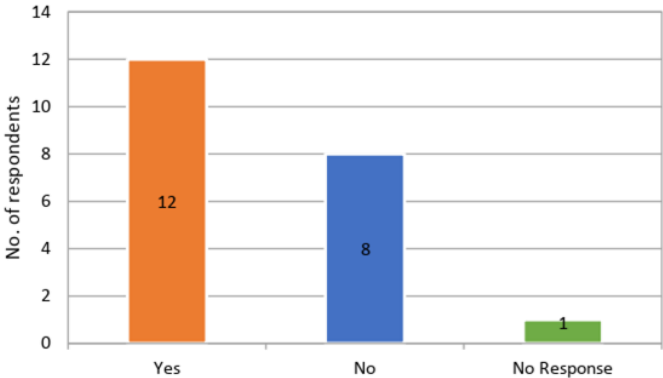
FIGURE 13A
COMMUNITY CONSULTATION
RESULTS

Are you aware that parts of Cootamundra are prone to flooding?

Is this property a residence, business or other?

Have you been affected by flooding from Muttama, Jindalee, Cootamundry or other creeks?

In total, 16 responses were received from the online survey in addition to another four hard copy responses. Most of these responses came from properties used as a residence (16) as opposed to those used for business (4). The responses highlighted that flooding in the area generally comes from the surrounding creeks and roads with most residents having experienced flooding in the front or backyard, or on roads outside the property. A summary of the survey results is provided on Figure 13 (Sheet A and B).

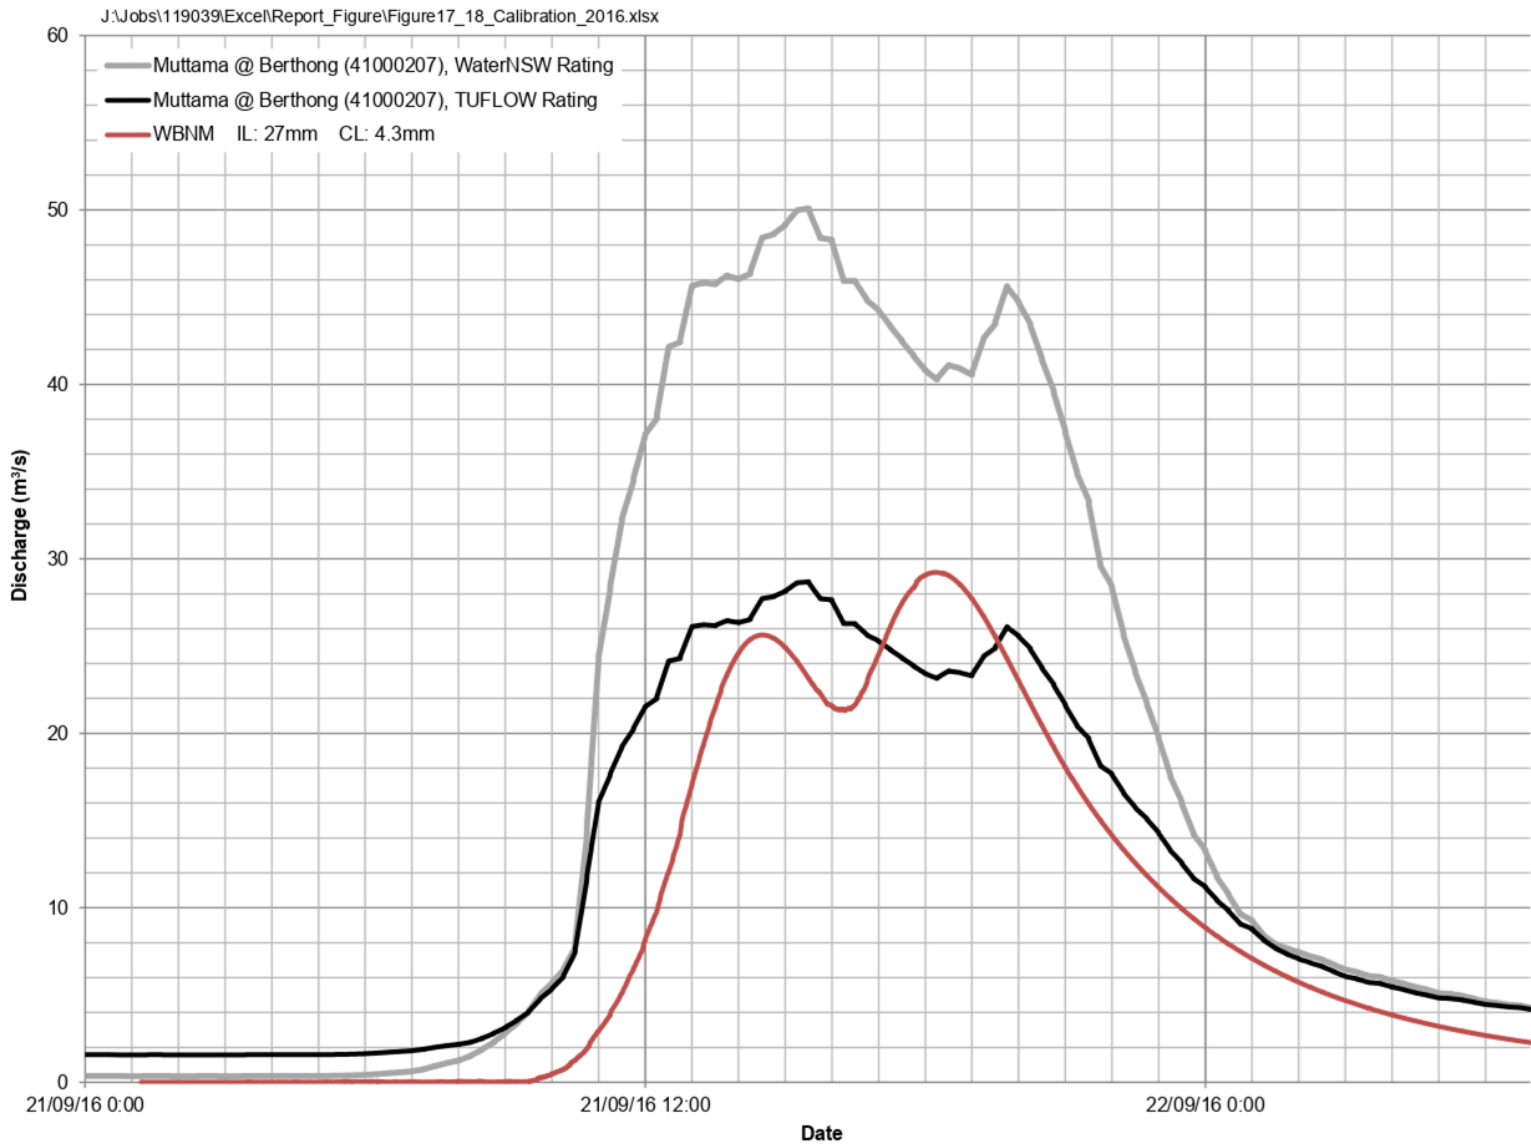
FIGURE 17
HYDROGRAPH - MUTTAMA CREEK AT BERTHONG ROAD STATION
SEPTEMBER 2016 - WBNM MODEL VS RECORDED HYDROGRAPH

Figure 17 shows the modelled and estimated flow for the September 2016 event at the Berthong Road gauge (41000207). Peak flow is overestimated by 0.5m³/s (or 2%) (Table 28). There is however a good match to the timing and shape of the estimated hydrograph except the WBNM model overestimates the second peak and underestimates the raising limb of the flood event. Overestimation of the second peak, this may be a result of the potentially different temporal pattern experienced in the Jindalee Creek portion of the catchment as described below.

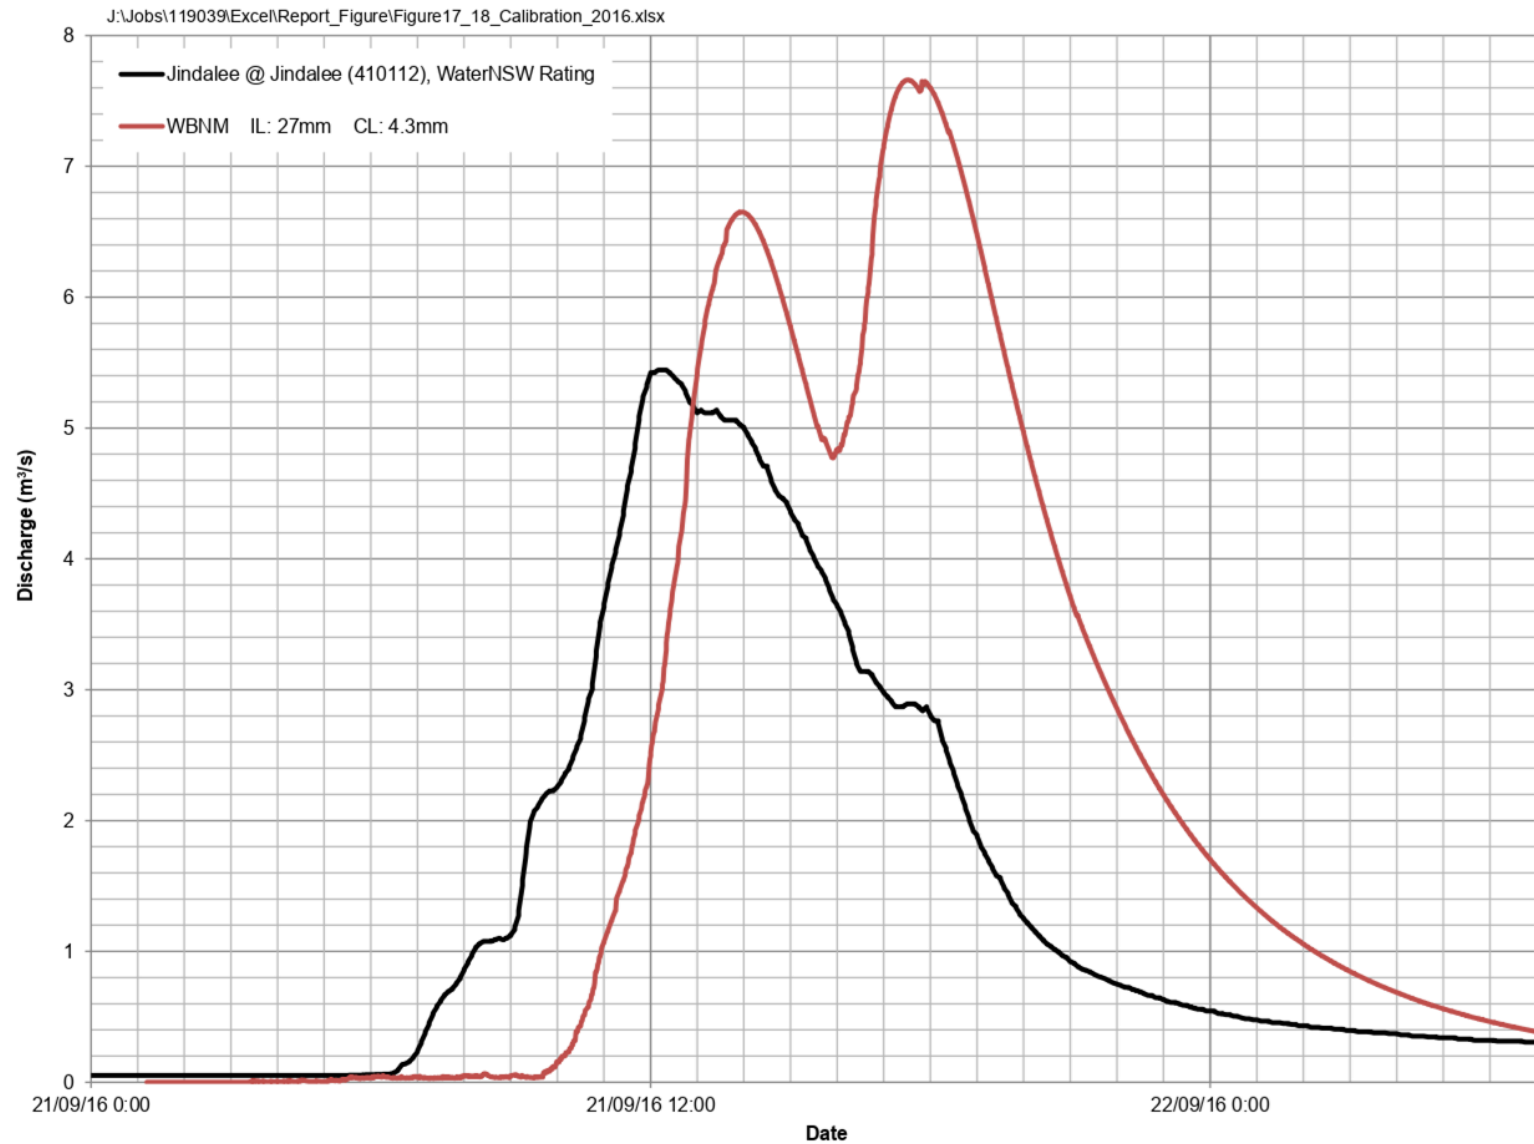
FIGURE 18
HYDROGRAPH AT JINDALEE CREEK AT JINDALEE STATION
SEPTEMBER 2016 - WBNM MODEL VS RECORDED HYDROGRAPH

A comparison was also made at the Jindalee gauge (410112). Figure 18 shows the modelled and estimated flow for the September 2016 event at the Jindalee gauge. The WBNM model overestimates the peak flow, peaking at 7.7m³/s in comparison to the recorded peak flow of 5.4m³/s. The recorded peak flow is based on the WaterNSW rating curve. It is also noted that the shape and timing of the hydrograph is not replicated by the WBNM model. It is likely that the upper part of the Jindalee catchment experienced only a single burst of rainfall, that was not recorded at the Jindalee rainfall gauge. There are no other pluviometer sites which could provide this temporal information.

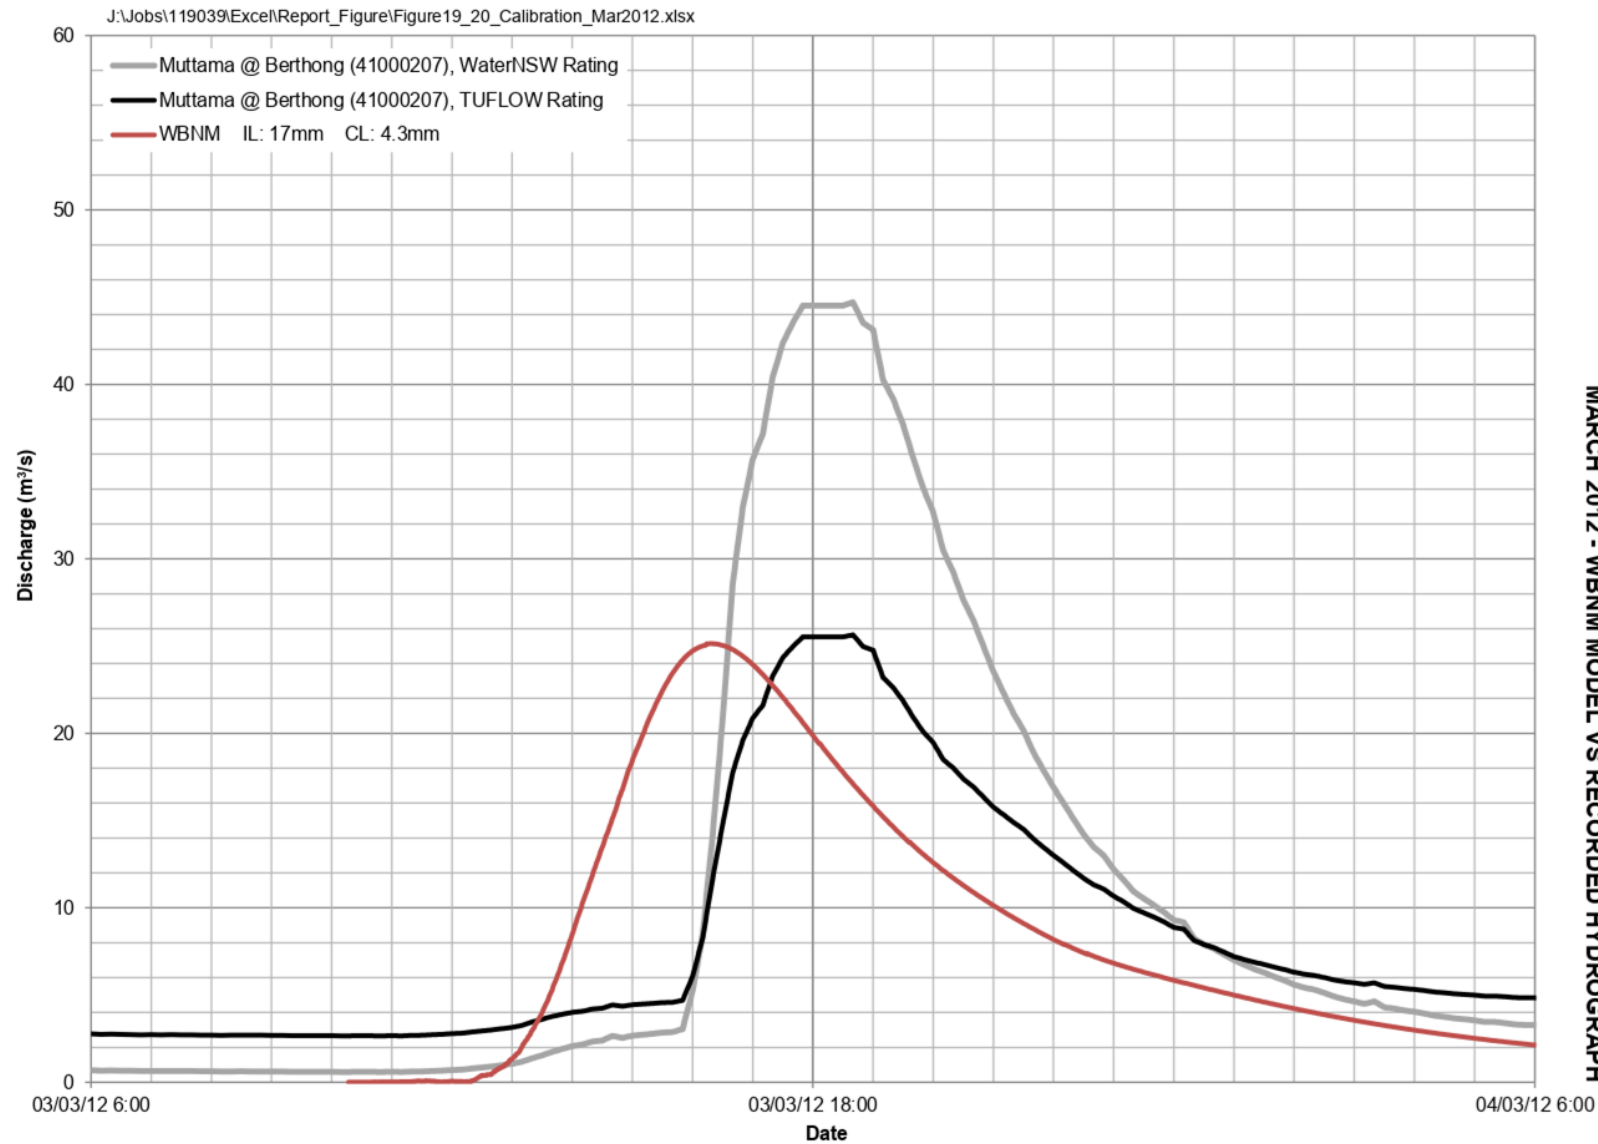
FIGURE 19
HYDROGRAPH - MUTTAMA CREEK AT BERTHONG ROAD STATION
MARCH 2012 - WBNM MODEL VS RECORDED HYDROGRAPH

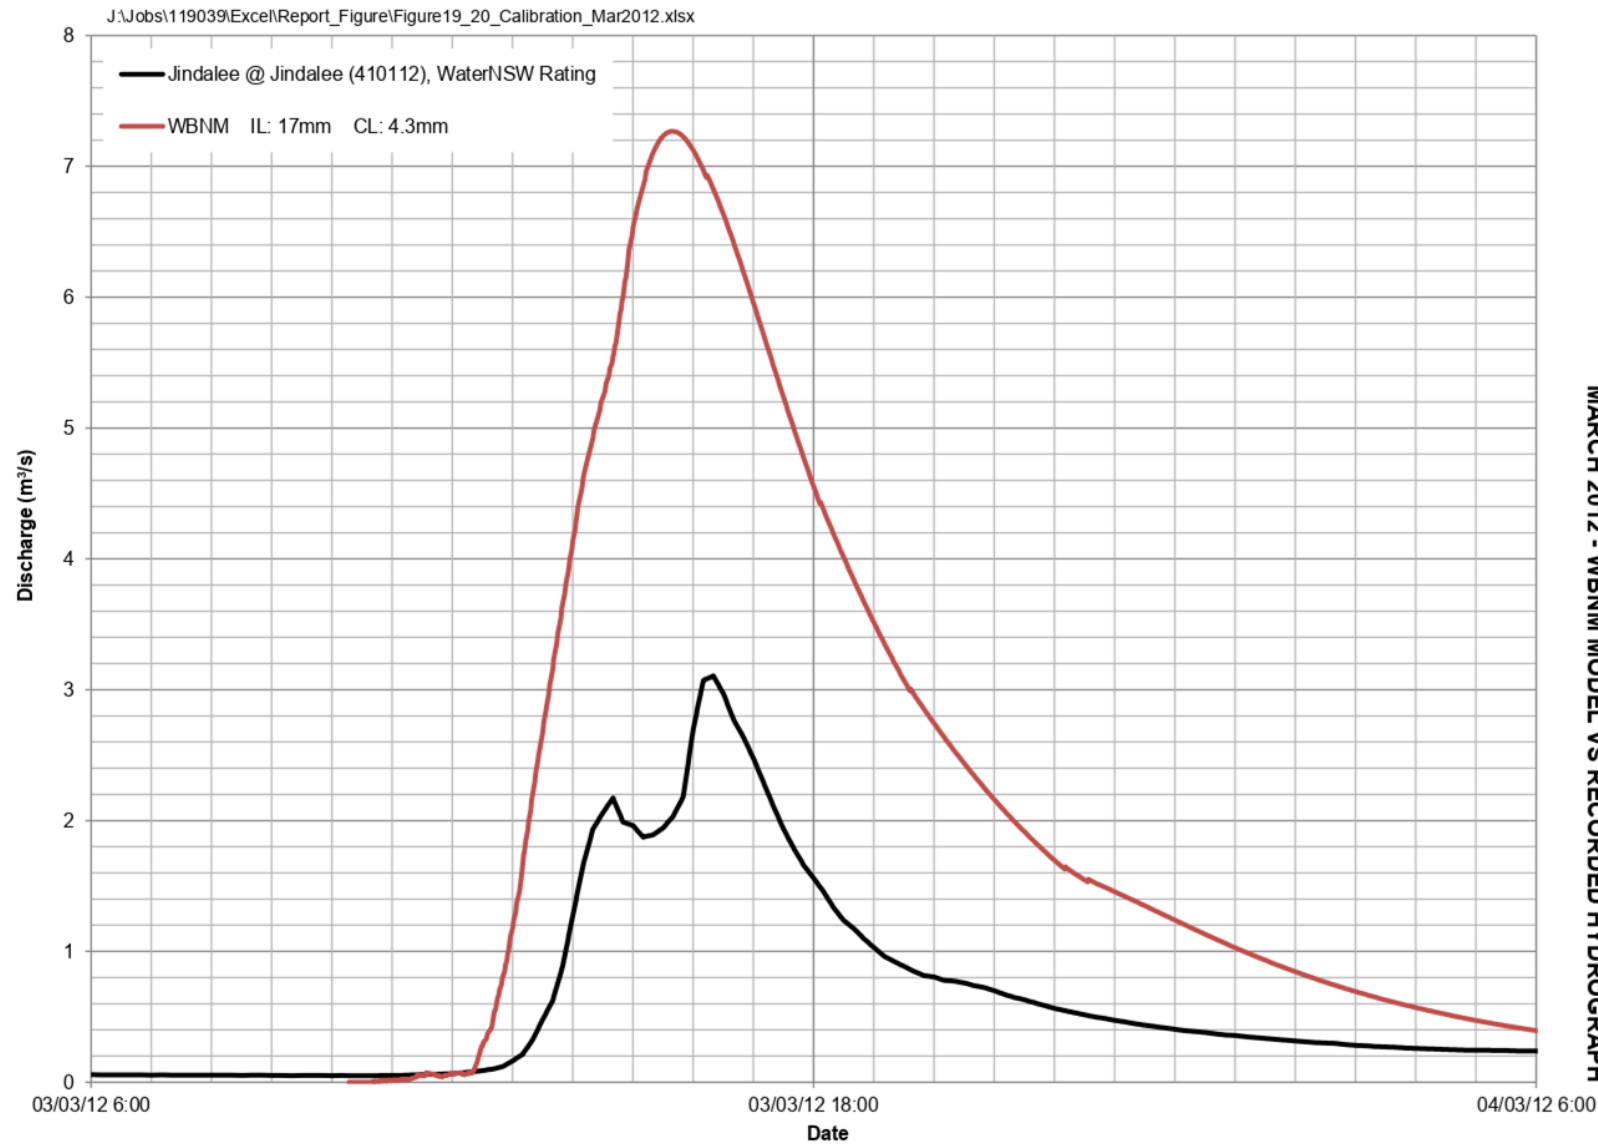
FIGURE 20
HYDROGRAPH AT JINDALEE CREEK AT JINDALEE STATION
MARCH 2012 - WBNM MODEL VS RECORDED HYDROGRAPH

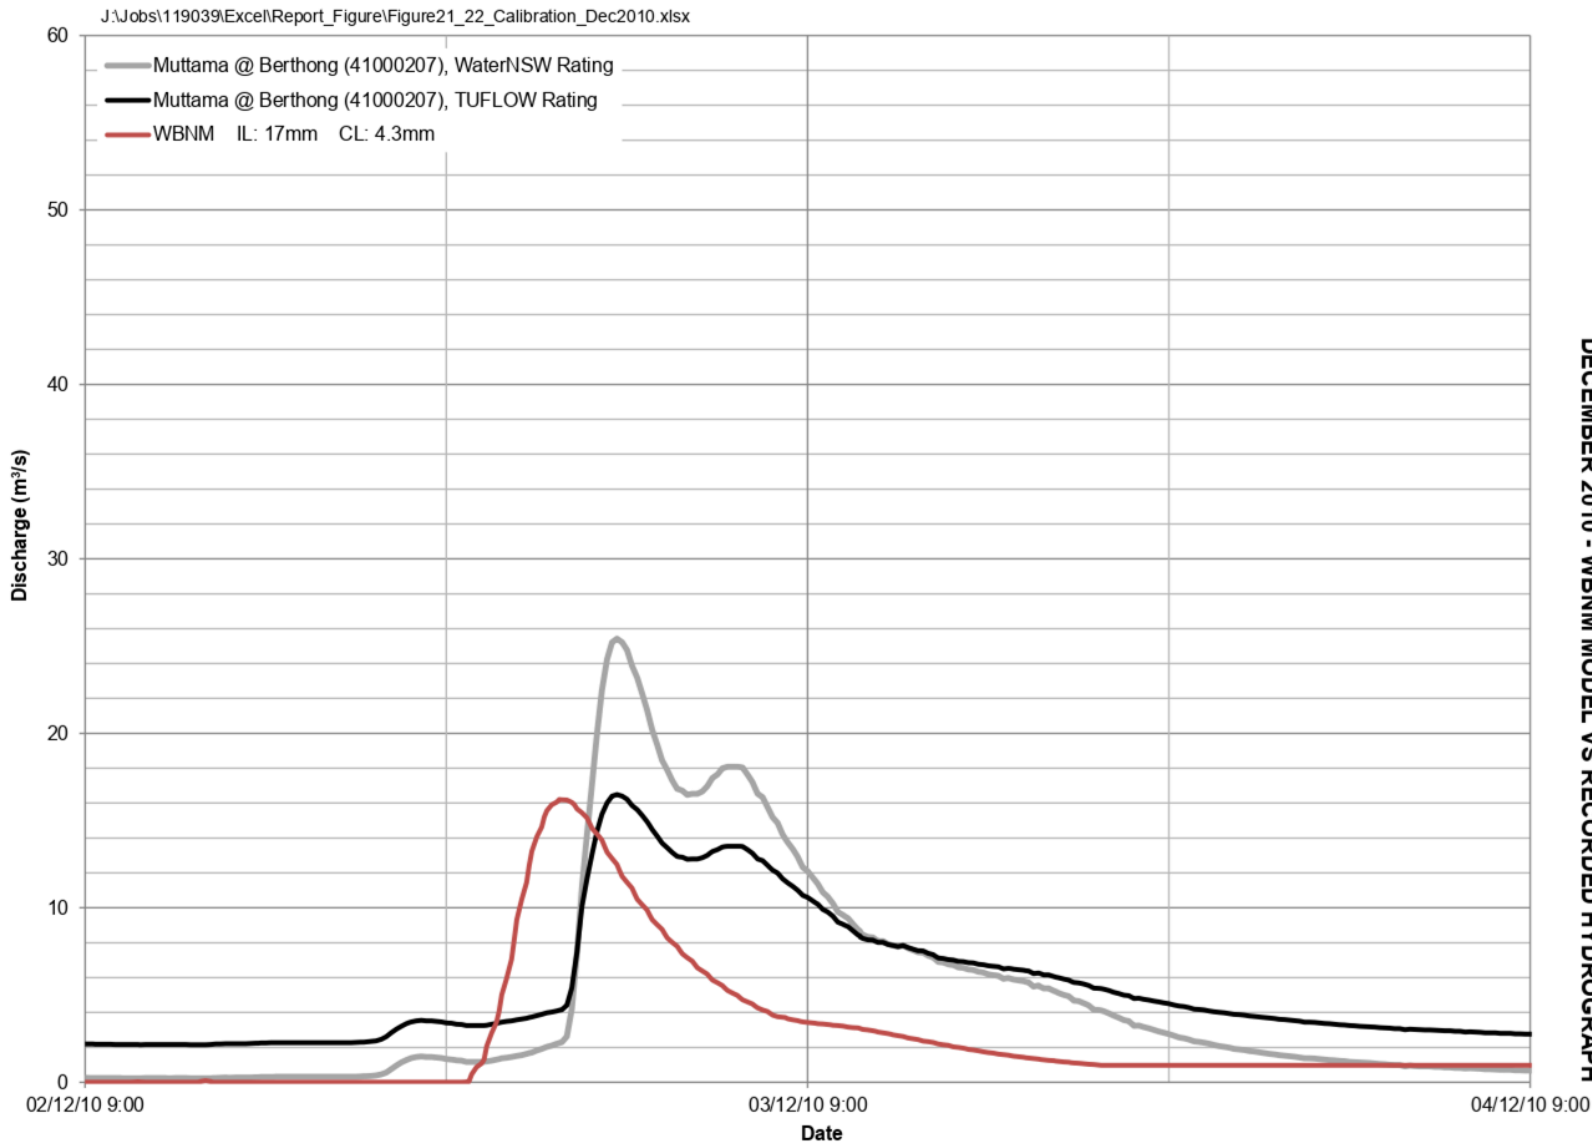
FIGURE 21
HYDROGRAPH - MUTTAMA CREEK AT BERTHONG ROAD STATION
DECEMBER 2010 - WBNM MODEL VS RECORDED HYDROGRAPH

Figure 21 shows the modelled and estimated flow for the December 2010 event at the Berthong Road gauge (41000207). The timing of the peak occurs 1 - 2 hours earlier in the WBNM model. The WBNM model captures the shape of the raising limb but doesn't reproduce the second peak in the hydrograph. It is likely that parts of the catchment experienced a slightly different temporal pattern during the storm event which was not captured at the available pluviometer sites. Modelling produces a good match to the recorded peak flow estimated with TUFLOW rating, with a difference of 2% as shown in Table 32.

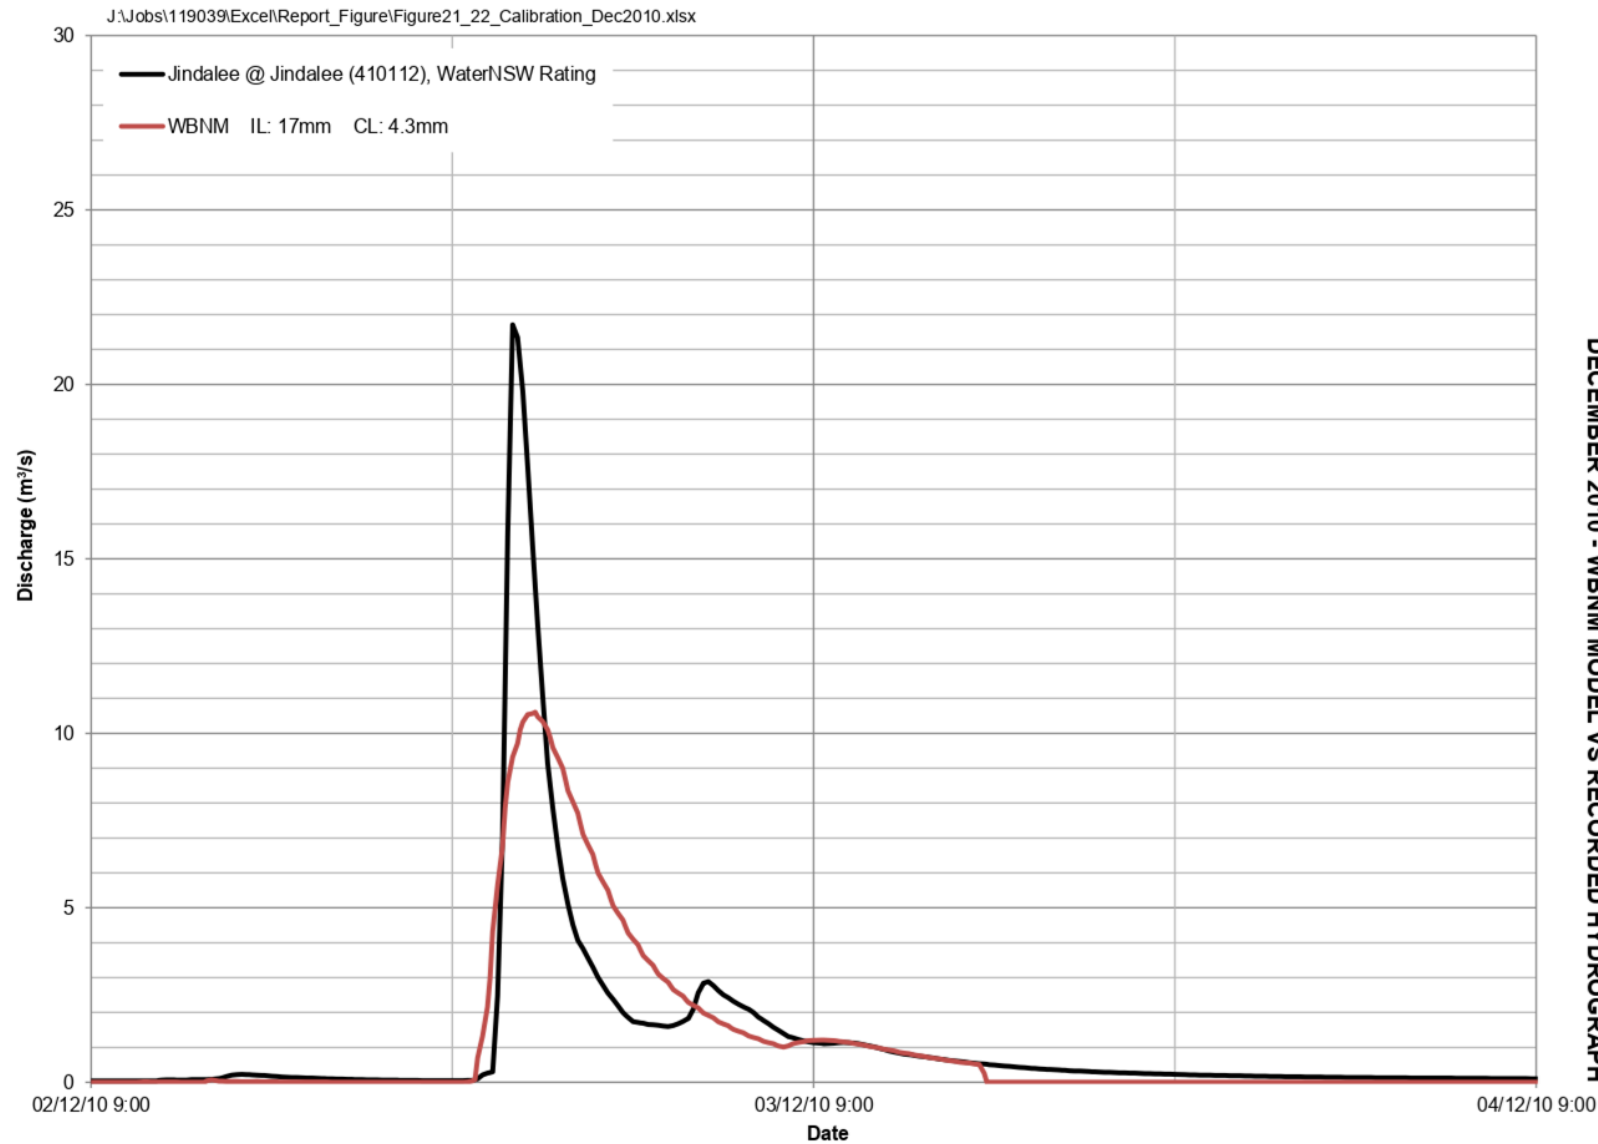
FIGURE 22
HYDROGRAPH AT JINDALEE CREEK AT JINDALEE STATION
DECEMBER 2010 - WBNM MODEL VS RECORDED HYDROGRAPH

Figure 22 shows the modelled and estimated flow for the December 2010 event at Jindalee gauge (410112). The WBNM model underestimates the peak flow by 11 m³/s, 10.6 m³/s (modelled) versus 21.7 m³/s (recorded). The recorded peak flow is based on the WaterNSW rating curve. The general shape of the rising and falling limb are reproduced. Figure 10 shows that the higher rainfalls were experienced over the northern and western portions of the catchment, where the Jindalee gauge is located. The sparse rainfall gauge network used to generate Figure 10 may be underestimating the rainfall the occurred in this portion of the catchment.

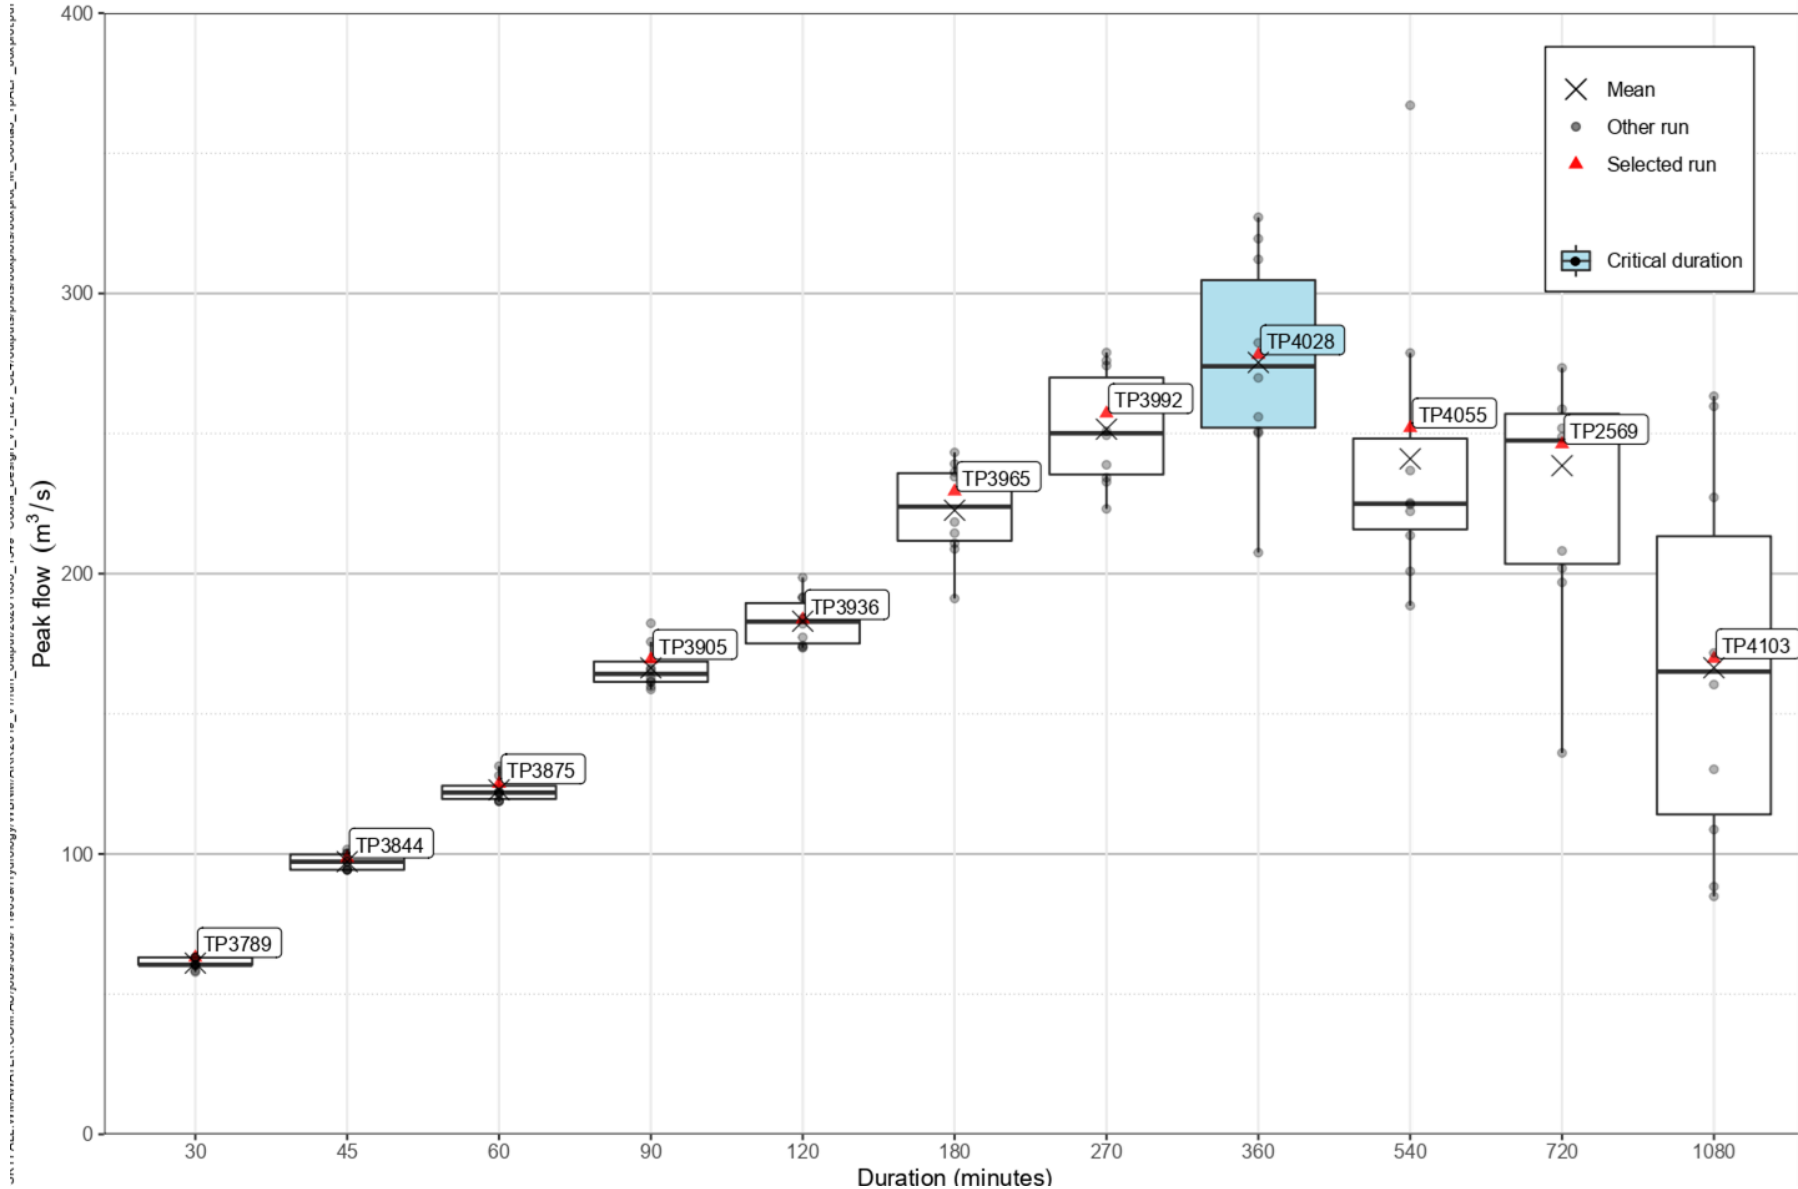
FIGURE 30
Subcatchment: M_Coota:
1% AEP Even
