**COOTAMUNDRA-GUNDAGAI
REGIONAL COUNCIL**

COOTAMUNDRA FLOOD STUDY

FINAL

JANUARY 2021

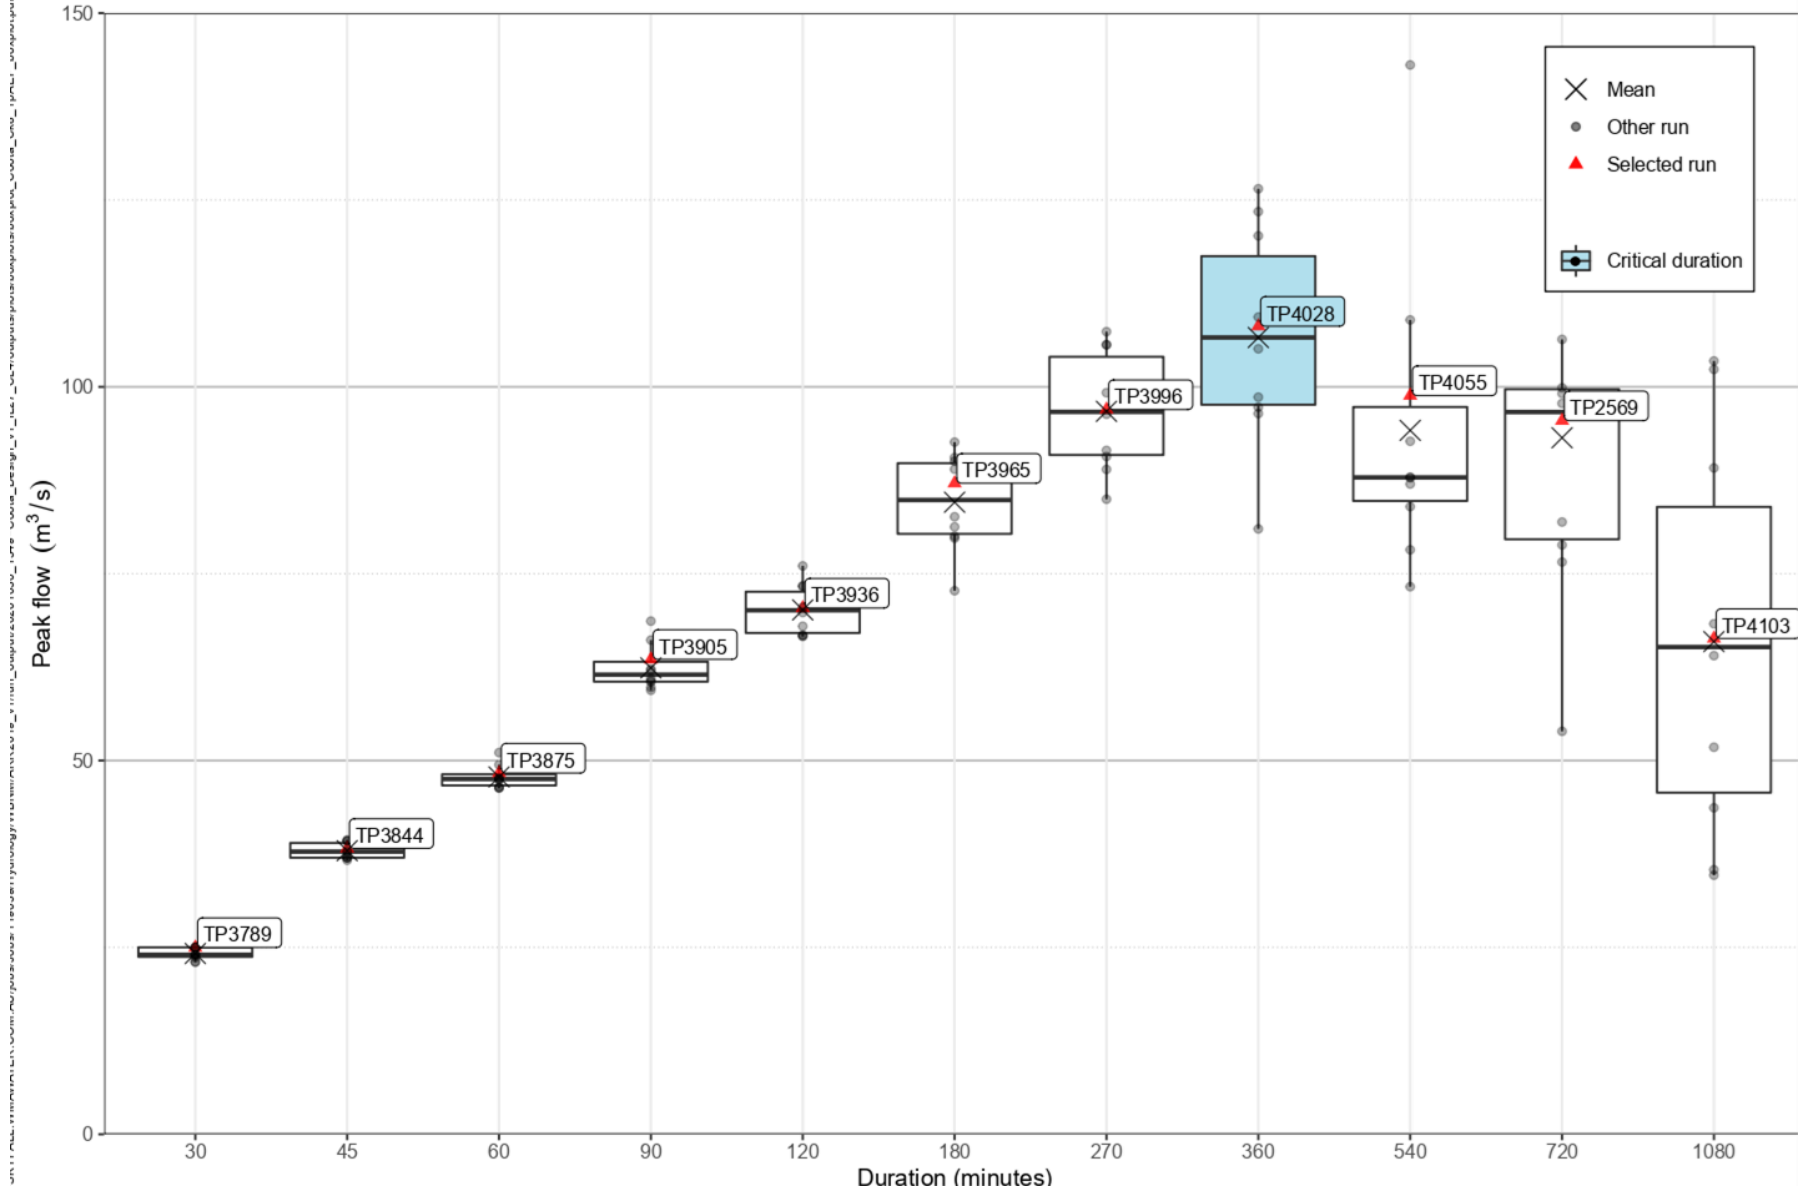
FIGURE 31
Subcatchment: Coota_Ckl
1% AEP Even

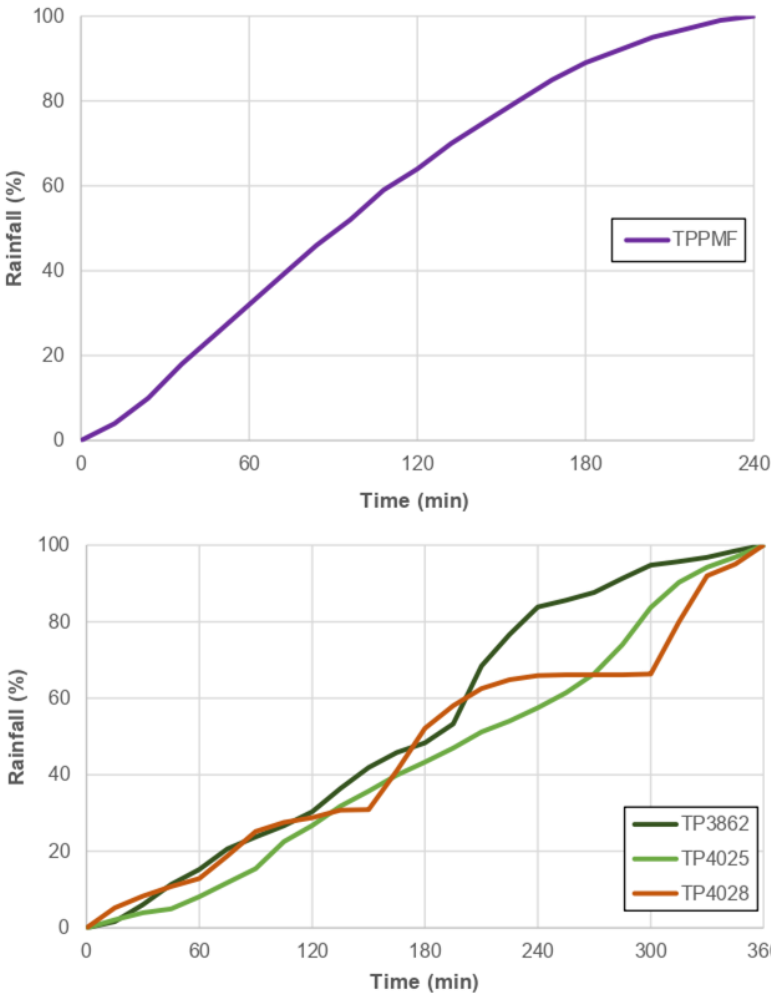
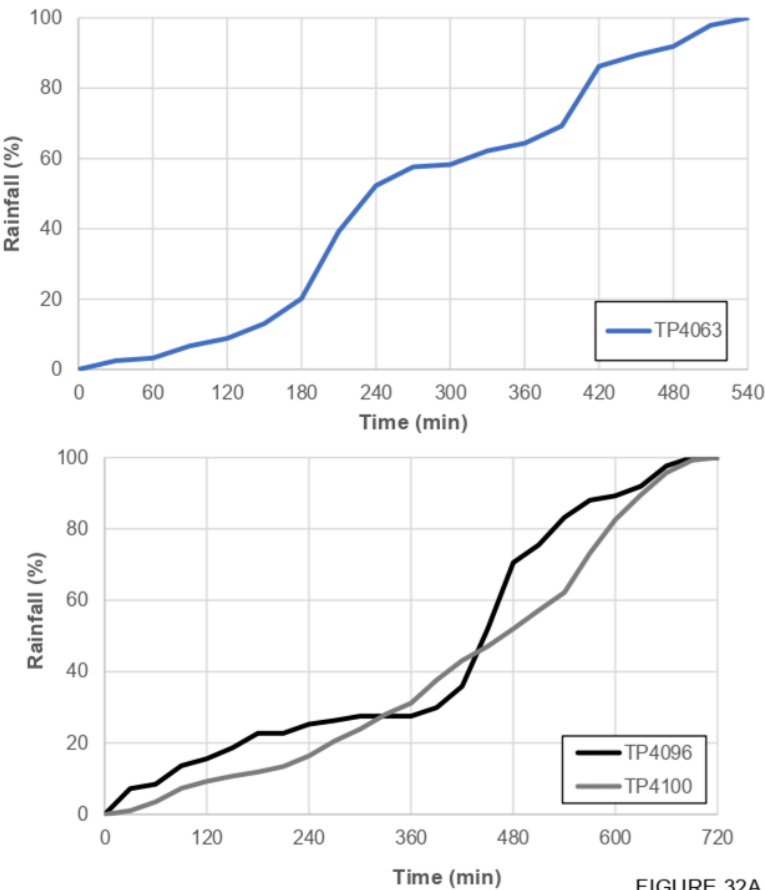
FIGURE 32A
ADOPTED DURATIONS AND TEMPORAL PATTERNS
FOR DESIGN FLOOD EVENTS
MAINSTREAM FLOODING

A summary of the adopted durations and temporal patterns for this study are shown in Table 39. Temporal patterns are shown on Figure 32: Adopted Durations and Temporal Patterns.

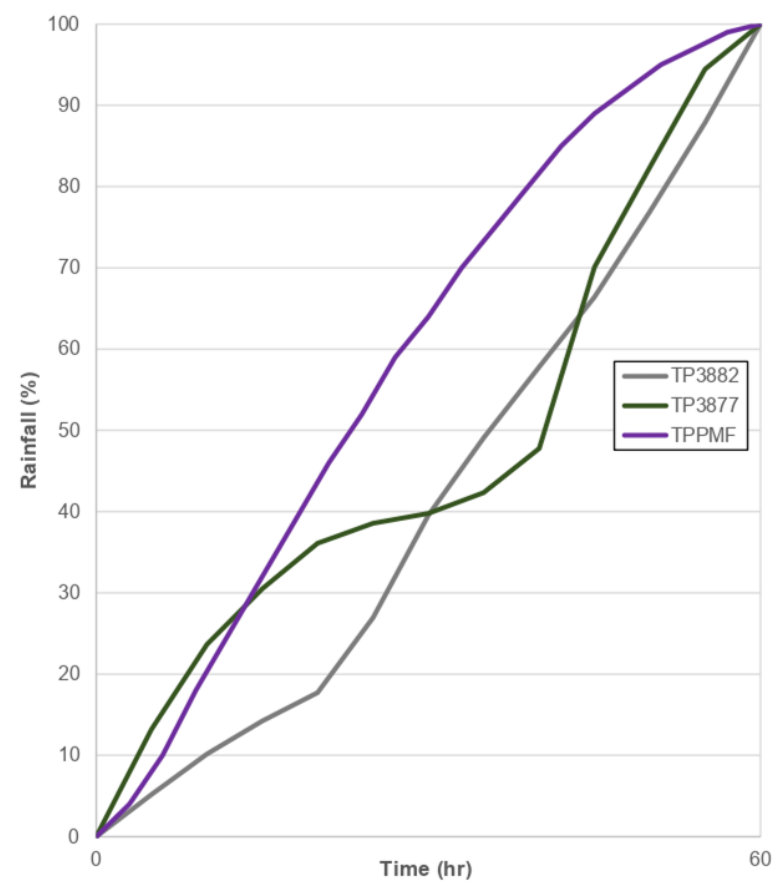
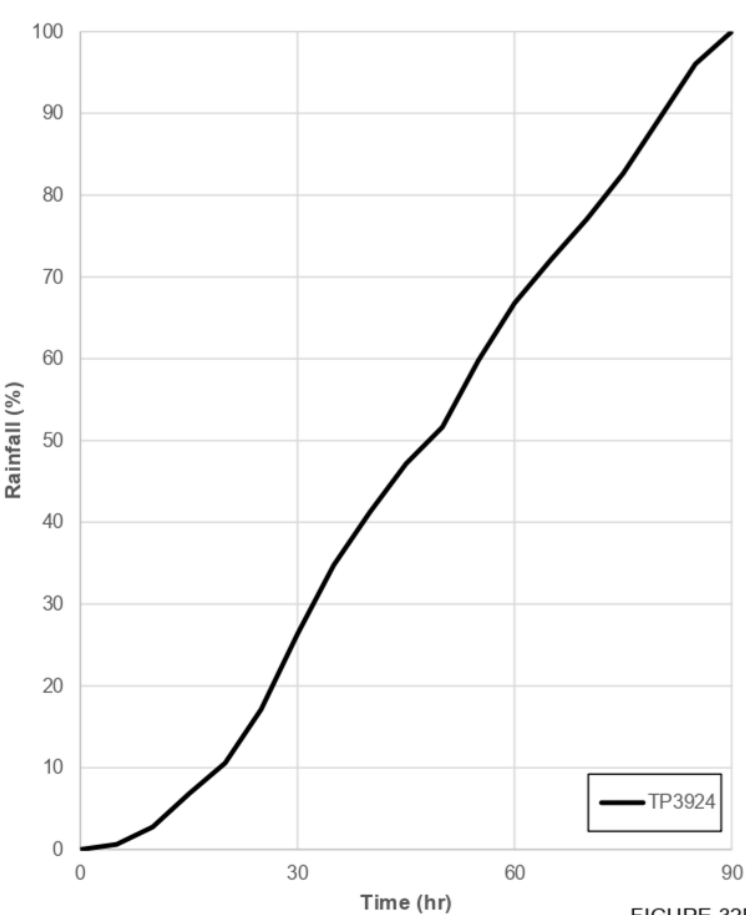
FIGURE 32B
ADOPTED DURATIONS AND TEMPORAL PATTERNS
FOR DESIGN FLOOD EVENTS
OVERLAND FLOODING

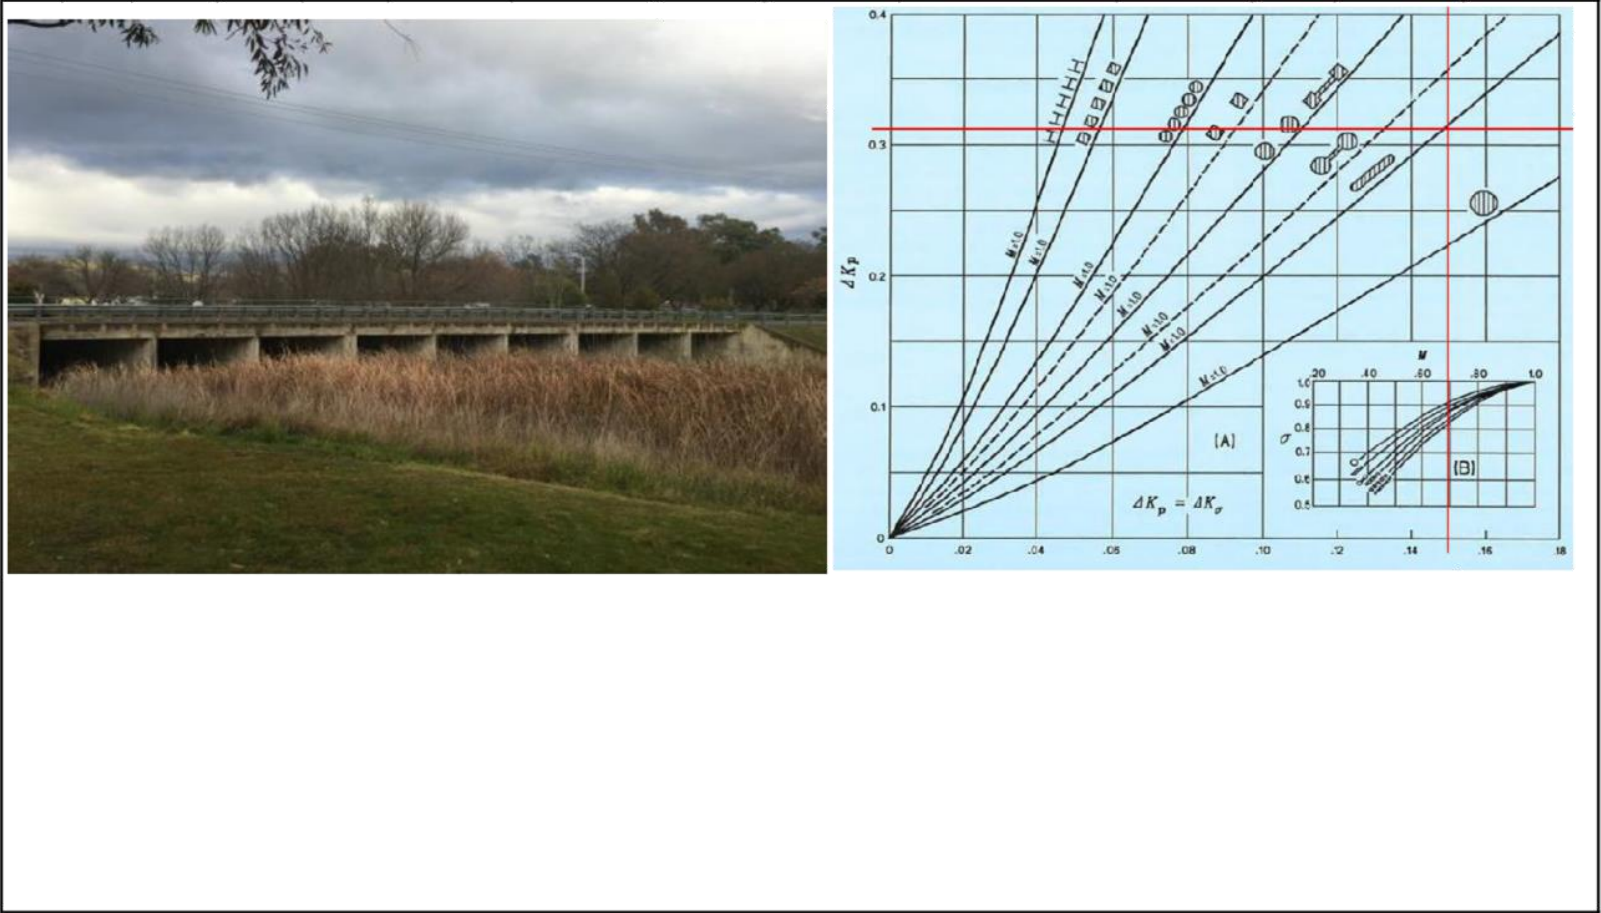
ID	Code	Width (m)	Height (m)	Number	Config	Name	Type	CreekName	Estimated/Measured	Loss	X	Y
6	E6	3.6	2.7	9	9 x 3.6	Wallendoon Street Bridge	Bridge	Muttama Creek	Measured	0.35	593735.5	6166646.28

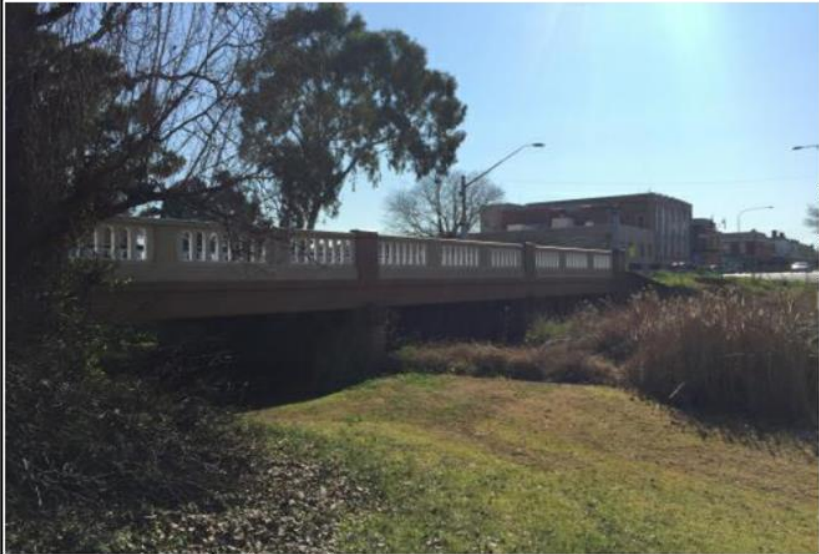
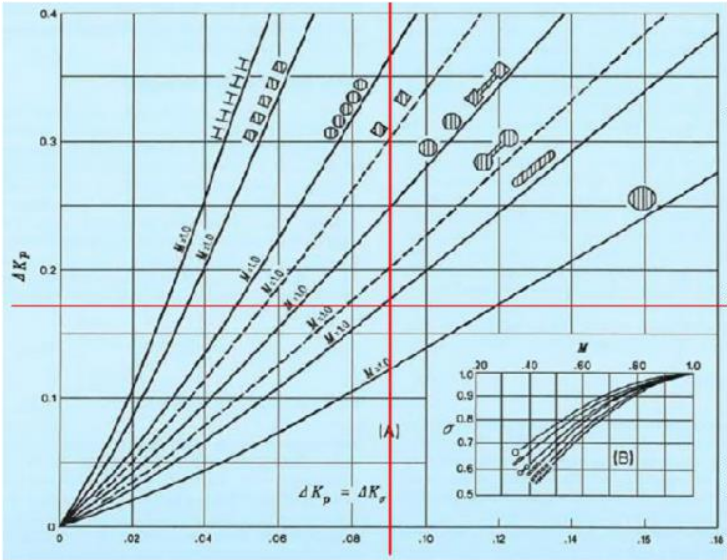
ID	Code	Width (m)	Height (m)	Number	Config	Name	Type	CreekName	Estimated/ Measured	Loss	X	Y
7	E7	8.5	2.1	3	3 x 8.5	Parker Street Bridge	Bridge	Muttama Creek	Measured	0.2	593774.96	6166441.79

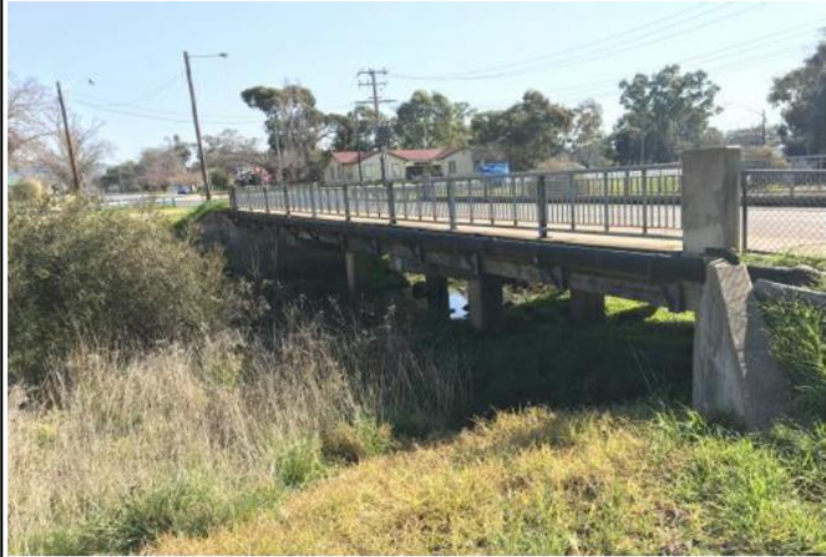
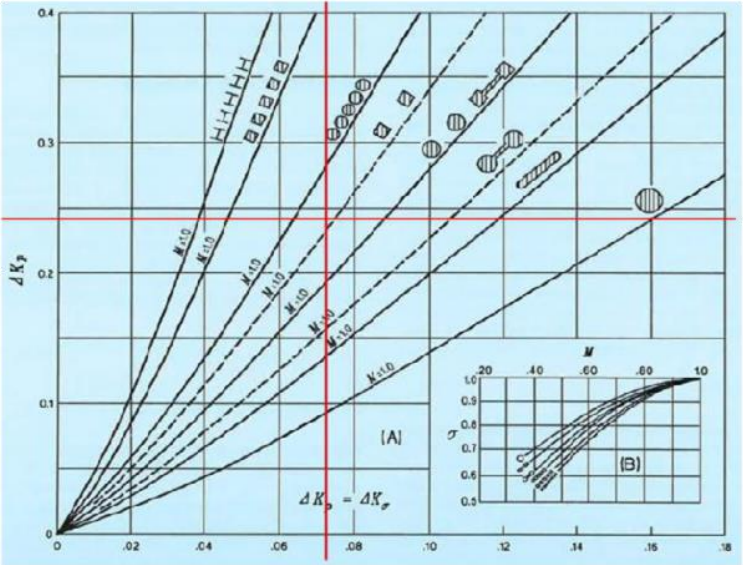
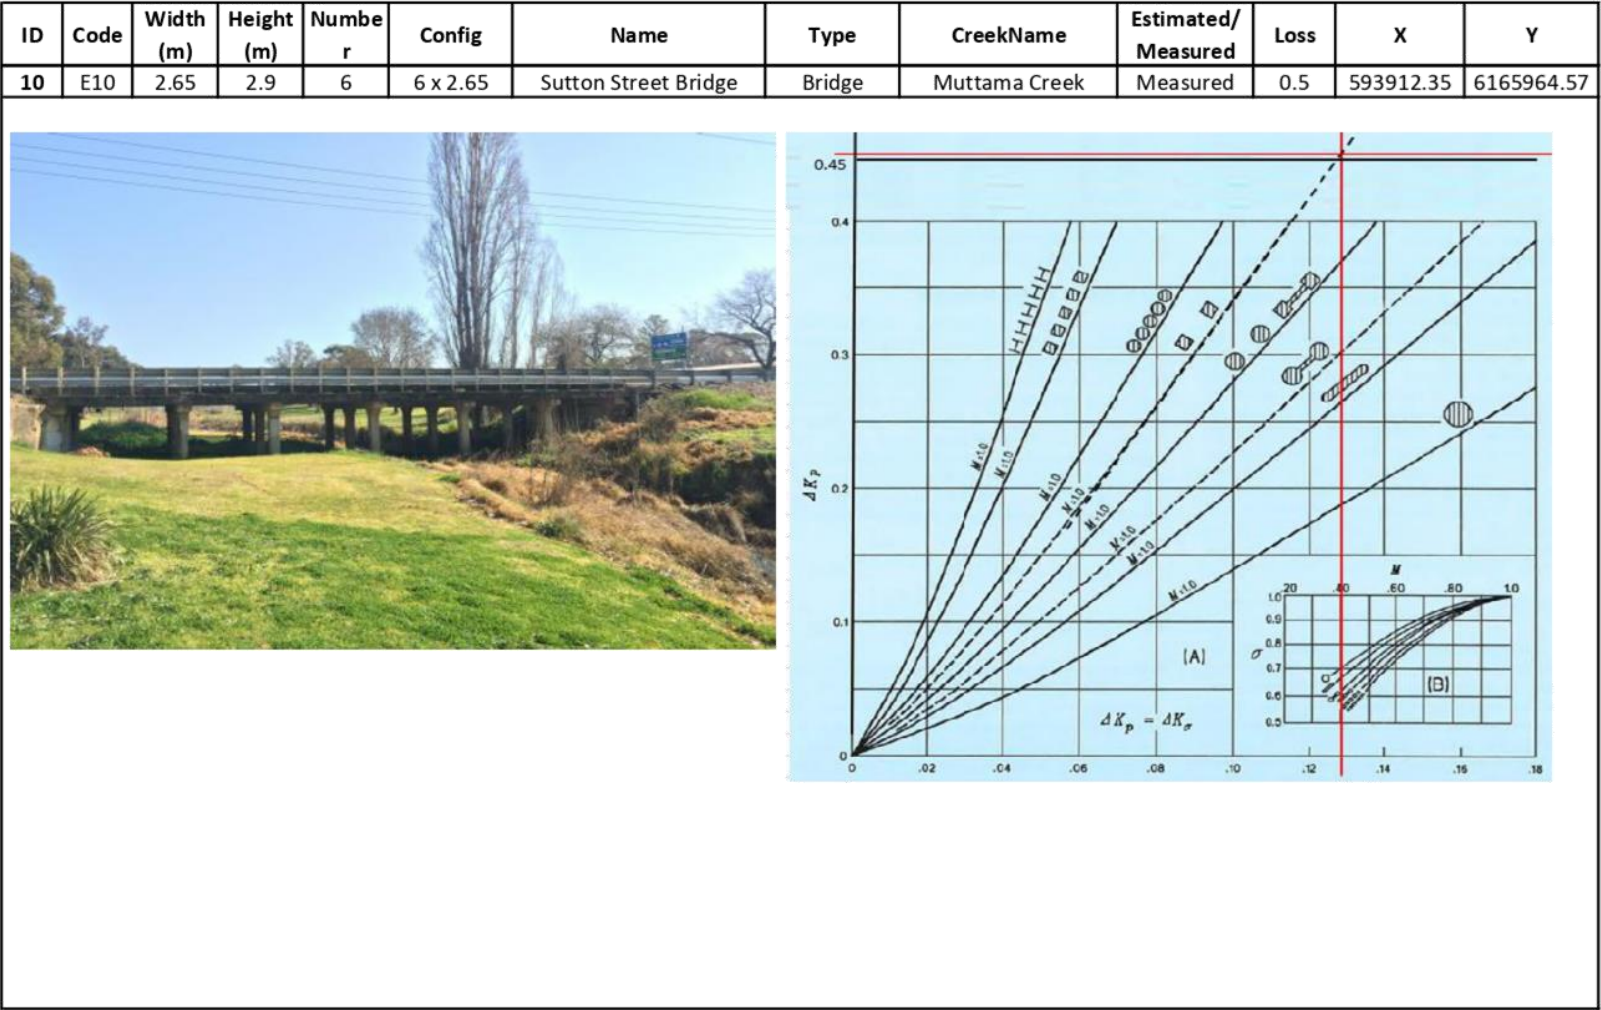
ID	Code	Width (m)	Height (m)	Number	Config	Name	Type	CreekName	Estimated/Measured	Loss	X	Y
8	E8	23.5	2.8	3	3 x 6.5	Mackay Street Bridge	Bridge	Muttama Creek	Measured	0.25	593749.42	6166332.79

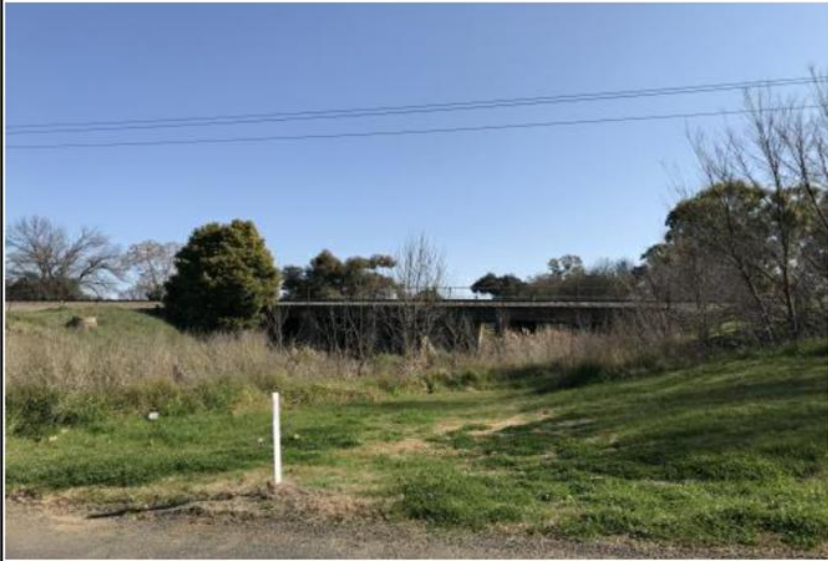
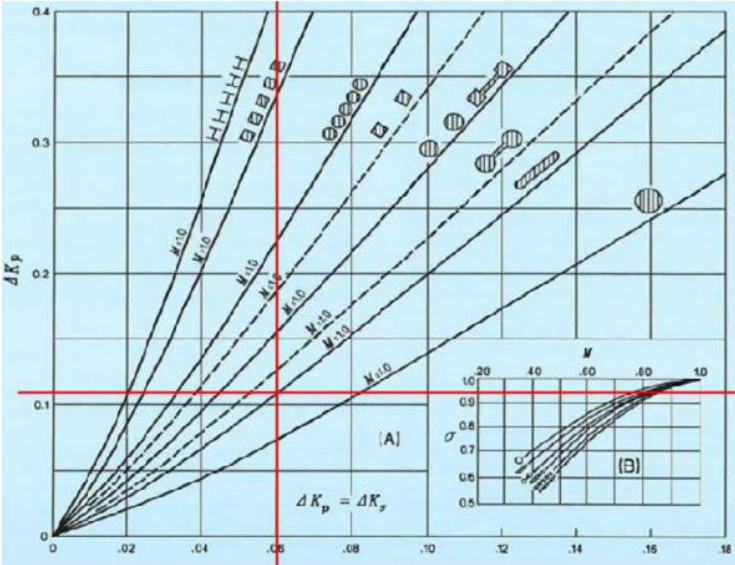
ID	Code	Width (m)	Height (m)	Number	Config	Name	Type	CreekName	Estimated/Measured	Loss	X	Y
12	E12	3	3	6	6 x 3	Main Southern Railway Bridge (A)	Bridge - Box Culvert	Muttama Creek	Measured	0.15	594079.41	6165807.17

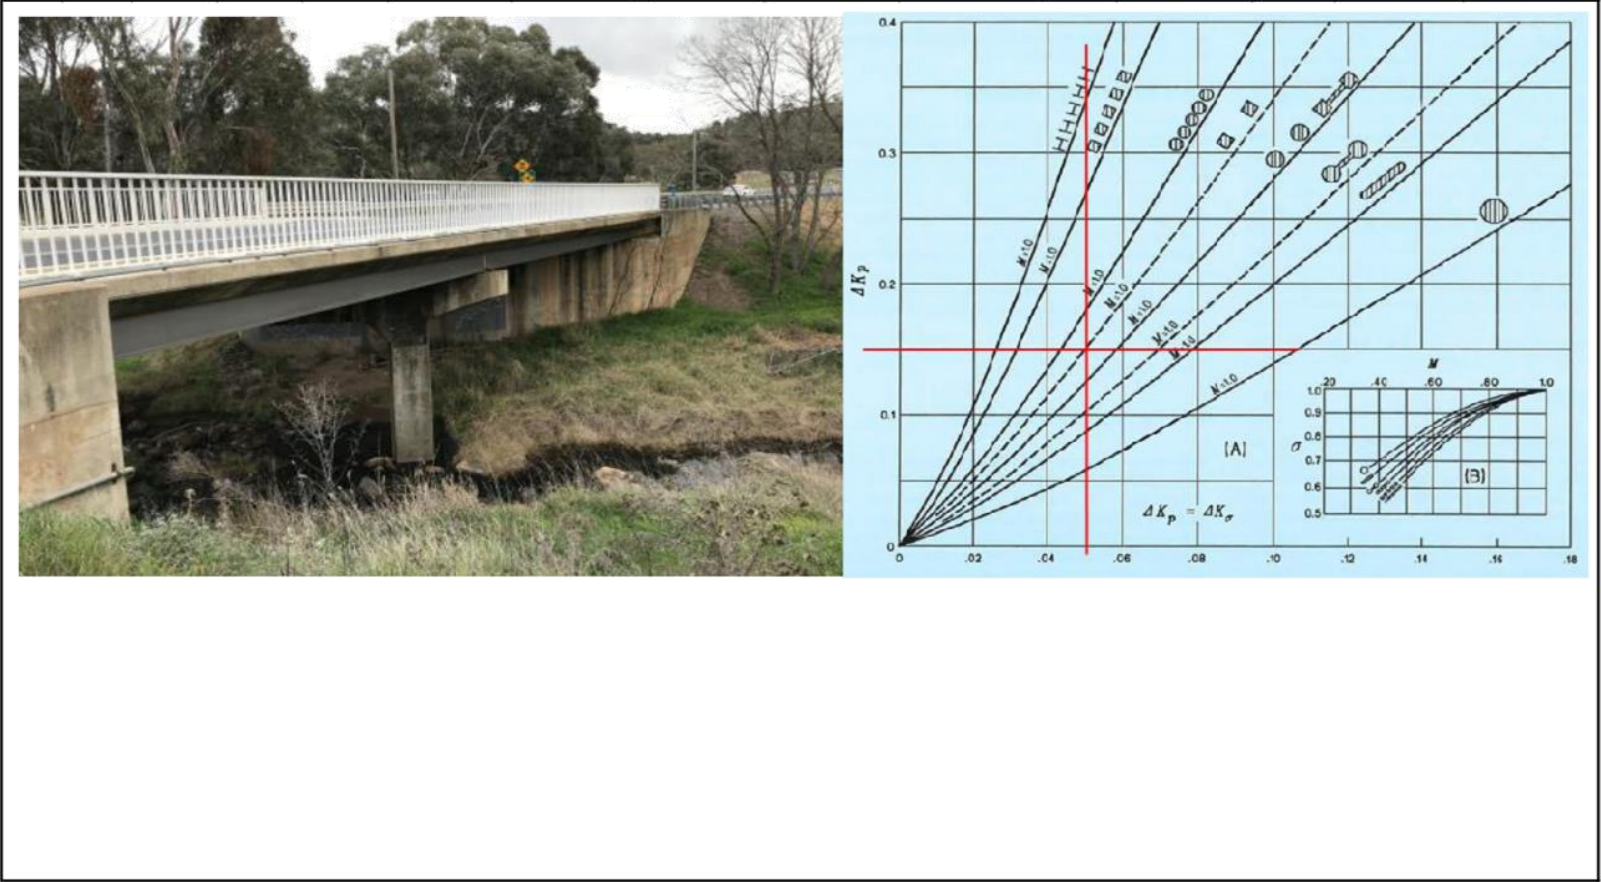
ID	Code	Width (m)	Height (m)	Number	Config	Name	Type	CreekName	Estimated/Measured	Loss	X	Y
17	E17	32.6	5	2	2 x 18	Olympic Highway Bridge (A)	Bridge	Cootamundra Creek tributary	Estimated	0.15	592957.78	6165008.69

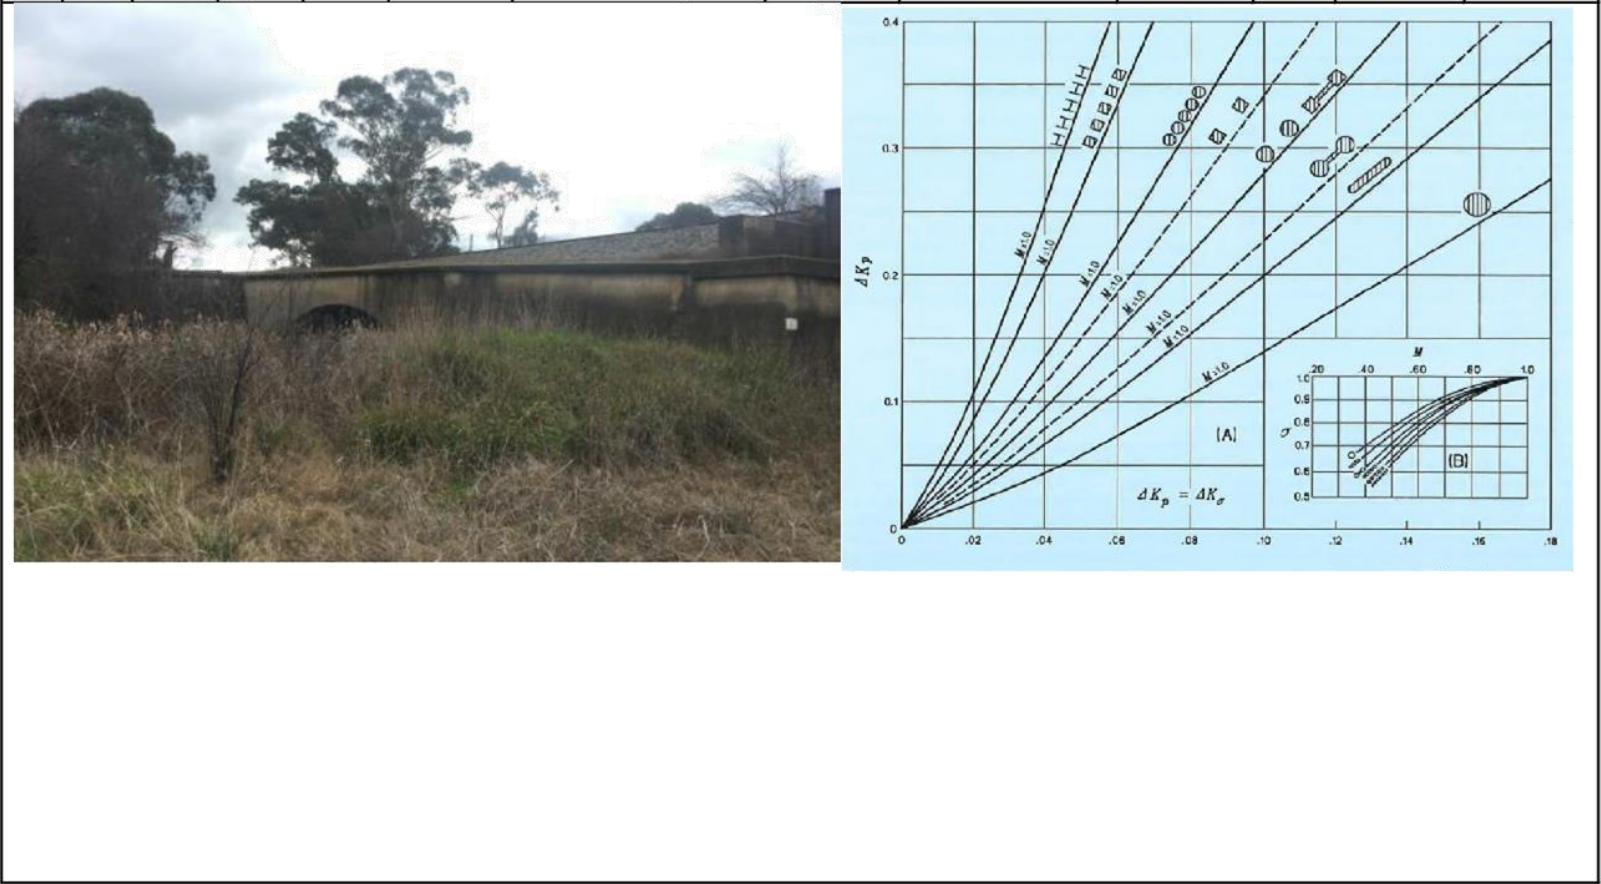
ID	Code	Width (m)	Height (m)	Number	Config	Name	Type	CreekName	Estimated/Measured	Loss	X	Y
37	A37	11.6	2.8	1	1 x 11.6	Main Southern Railway Underbridge	Bridge	Cootamundra Creek	Measured	0	592994.21	6164961.9

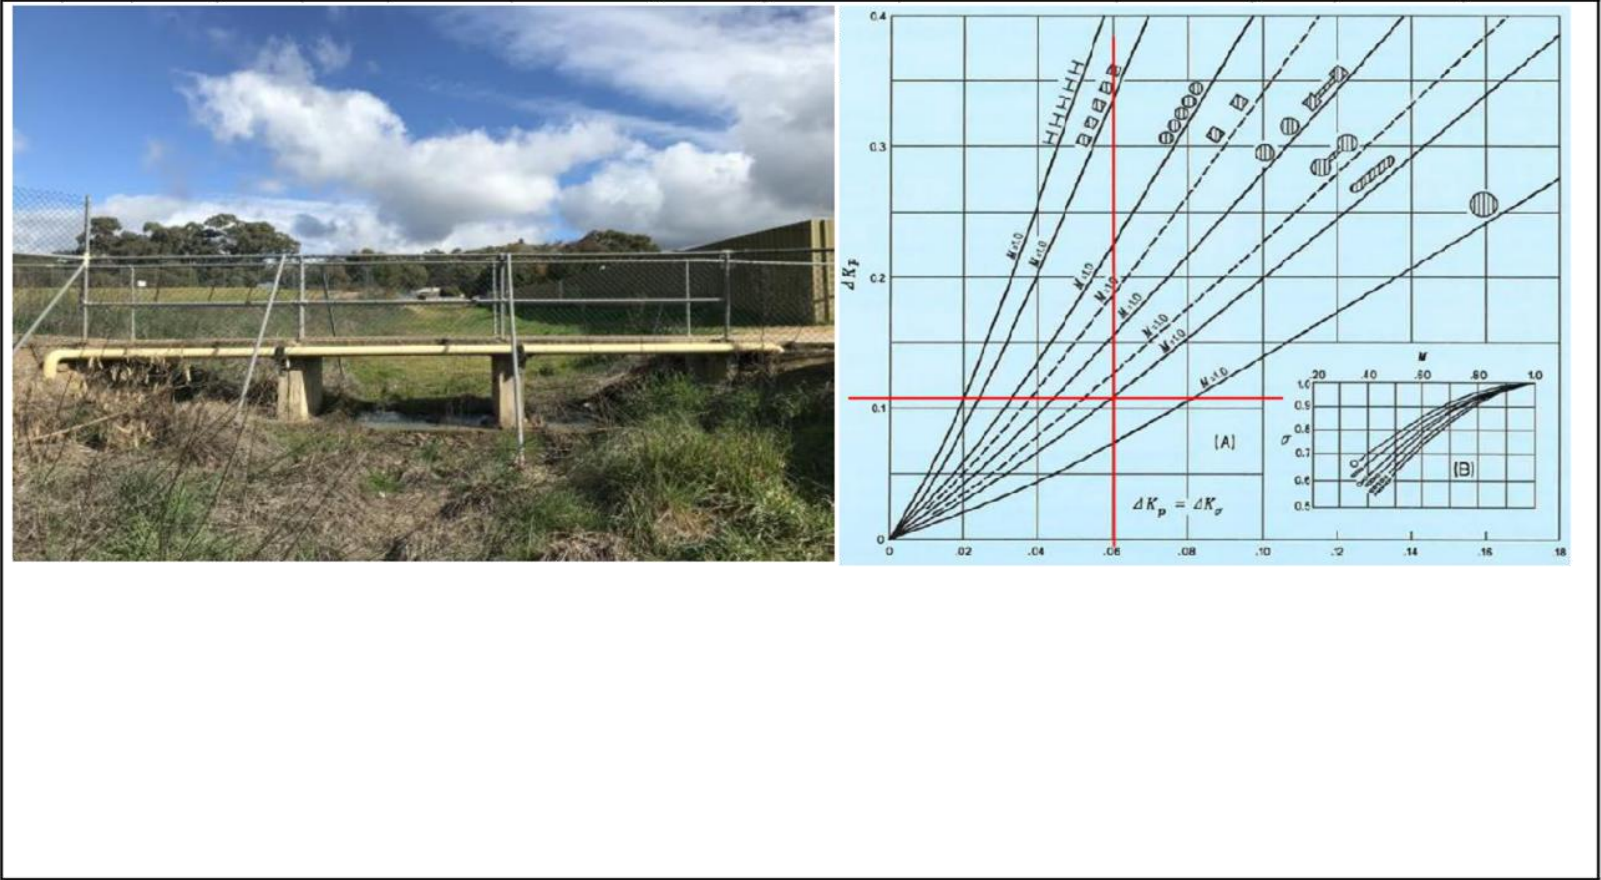
ID	Code	Width (m)	Height (m)	Number	Config	Name	Type	CreekName	Estimated/Measured	Loss	X	Y
41	A41	2.15	0.9	3	3 x 2.15	Scott Avenue Pedestrian Bridge	Culvert	Muttama Creek	Measured	0.15	592791.03	6167148.05

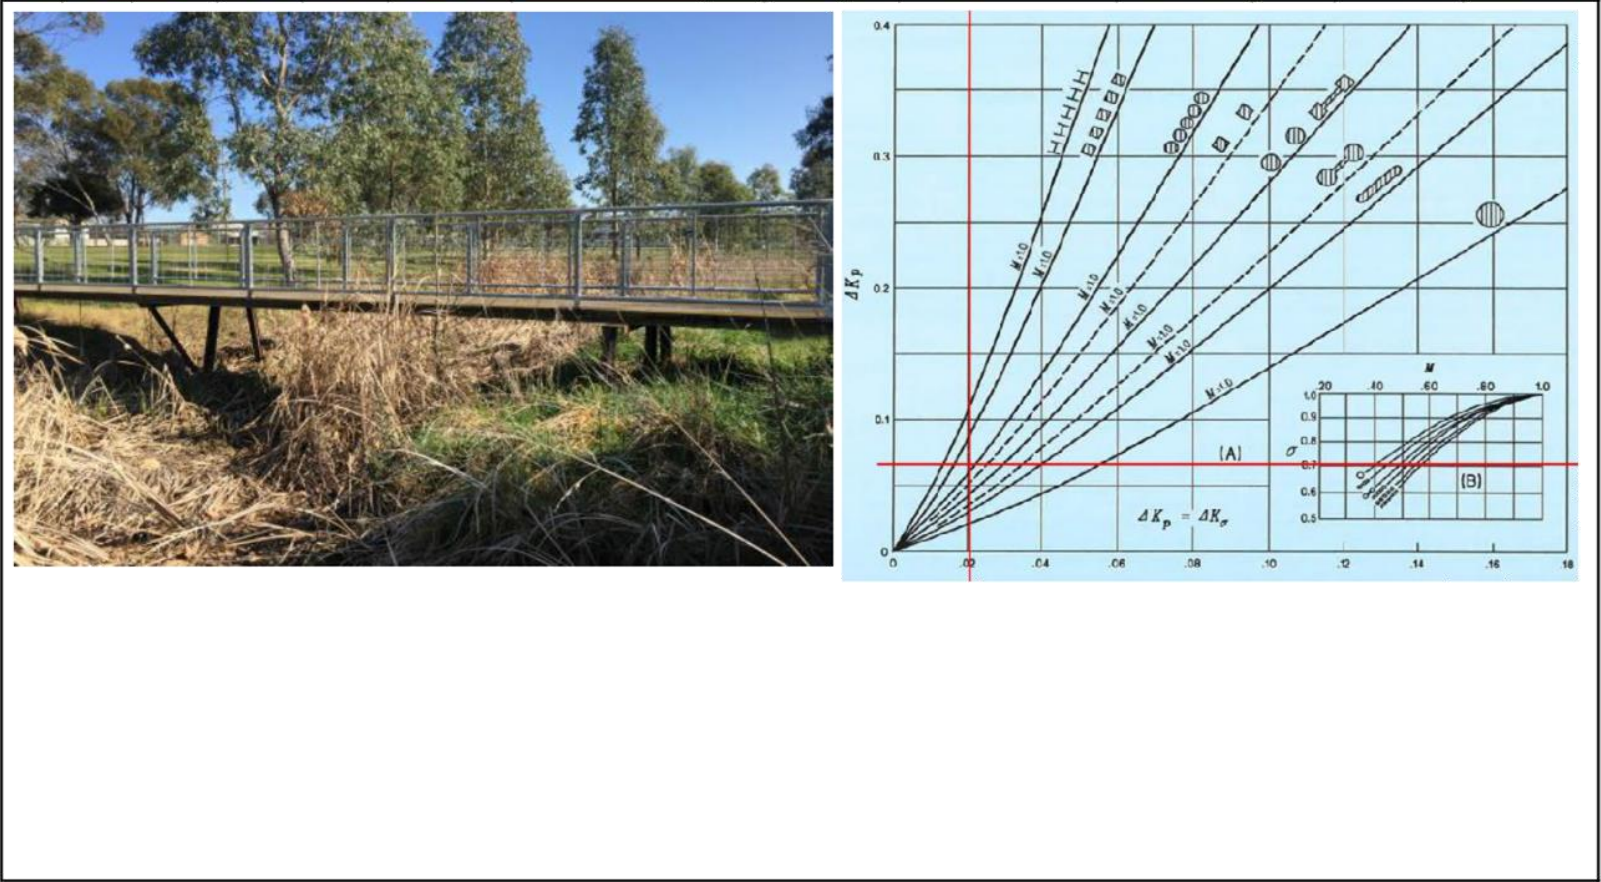
ID	Code	Width (m)	Height (m)	Number	Config	Name	Type	CreekName	Estimated/Measured	Loss	X	Y
54	A54	28	2.3	2	3 x 9	Thompson Street Pedestrian Bridge	Pedestrian Bridge	Muttama Creek	Measured	0.1	593799.34	6166062.57

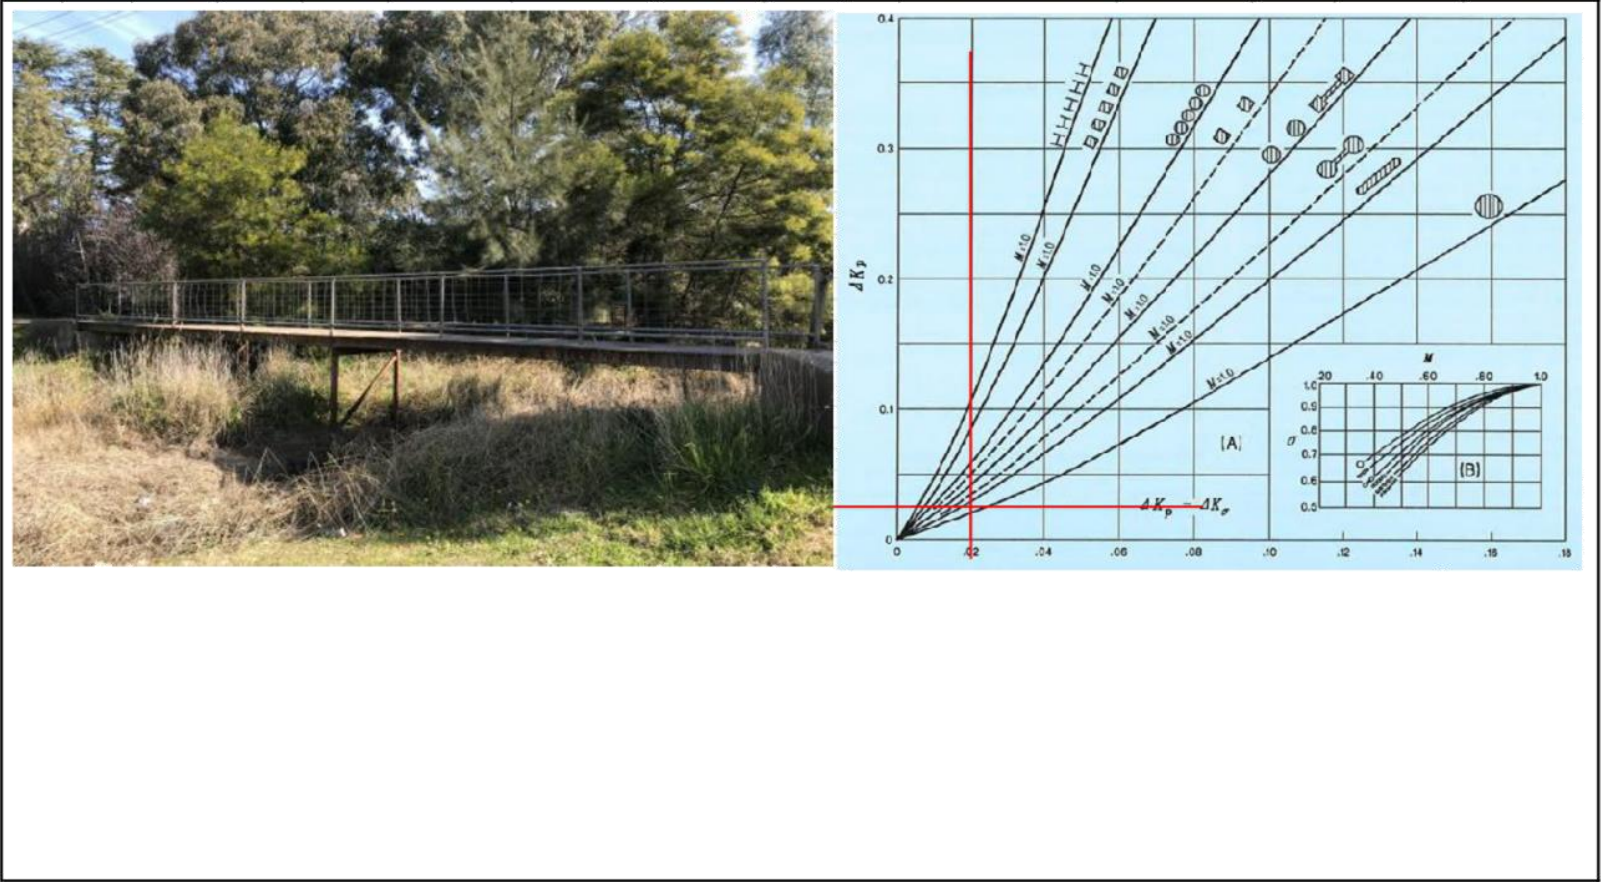
ID	Code	Width (m)	Height (m)	Number	Config	Name	Type	CreekName	Estimated/Measured	Loss	X	Y
55	A55	15	1.8	1	2 x 7.5	Poole Street Pedestrian Bridge	Pedestrian Bridge	Muttama Creek	Measured	0.05	593506.63	6166996.32

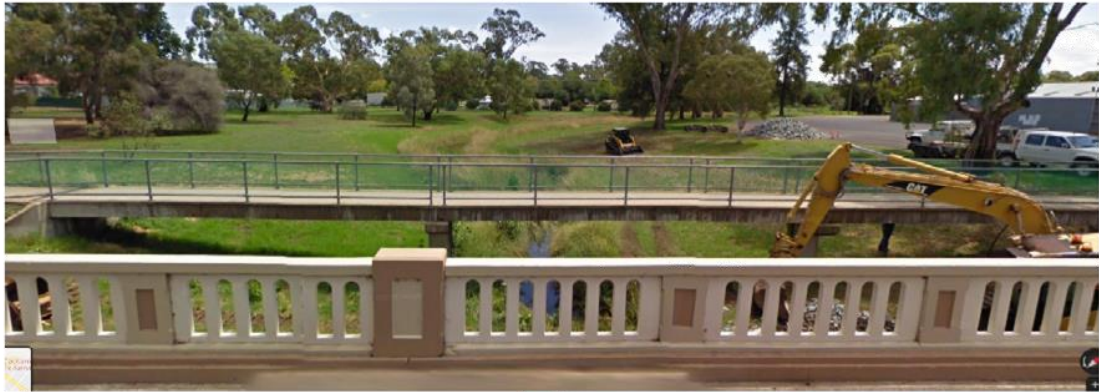
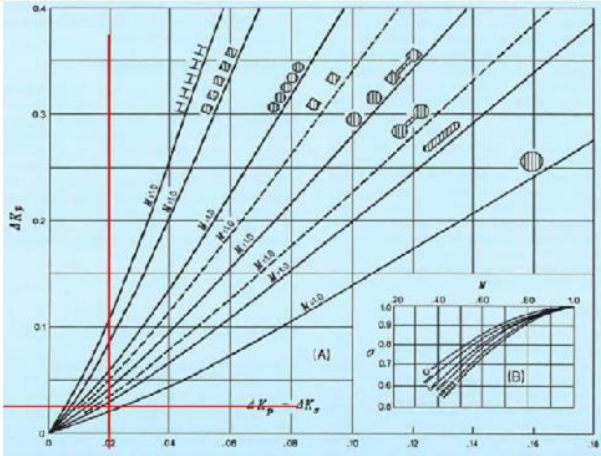
ID	Code	Width (m)	Height (m)	Number	Config	Name	Type	CreekName	Estimated/Measured	Loss	X	Y
61	A61	28	2.54	2	3 x 9	Parker Street Pedestrian Bridge	Pedestrian Bridge	Muttama Creek	Measured	0.05	593763.66	6166449.81
<div>

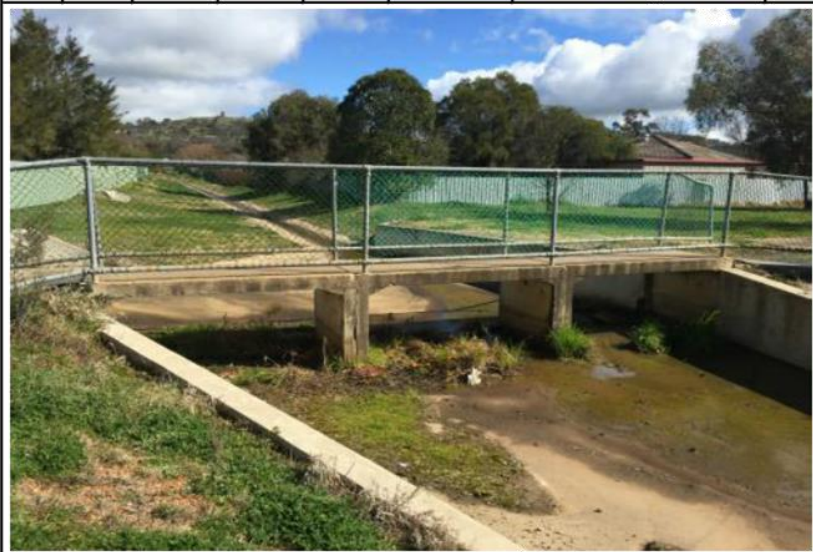
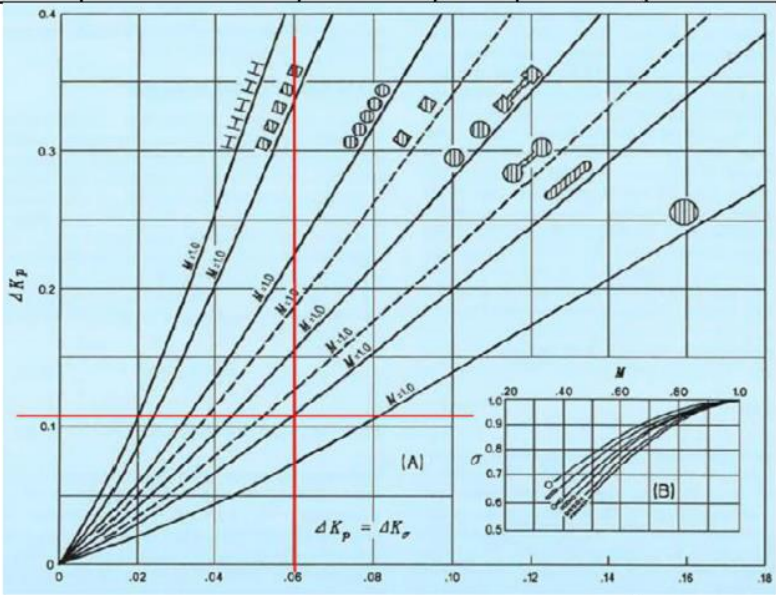
ID	Code	Width (m)	Height (m)	Number	Config	Name	Type	CreekName	Estimated/Measured	Loss	X	Y
69	A69	2	0.9	3	3 x 2	Scott Avenue Pedestrian Bridge	Culvert	Inala Channel	Measured	0.15	593151.82	6167200.83

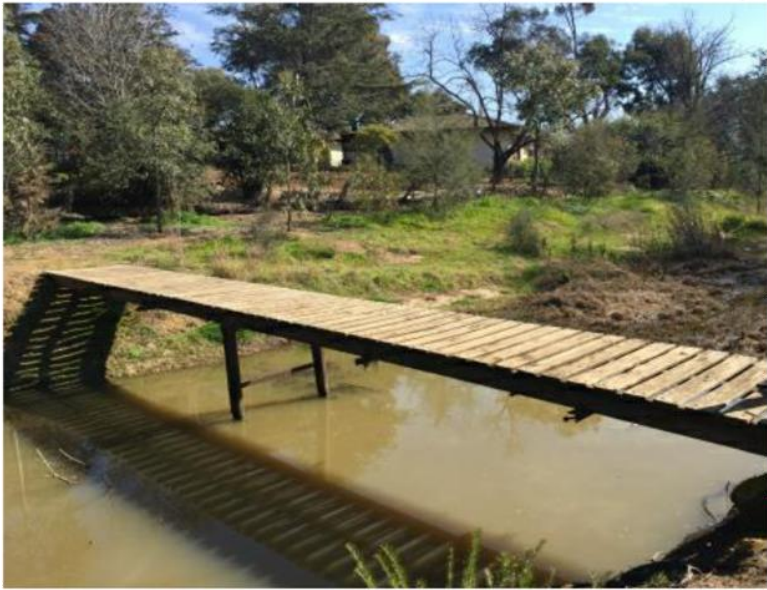
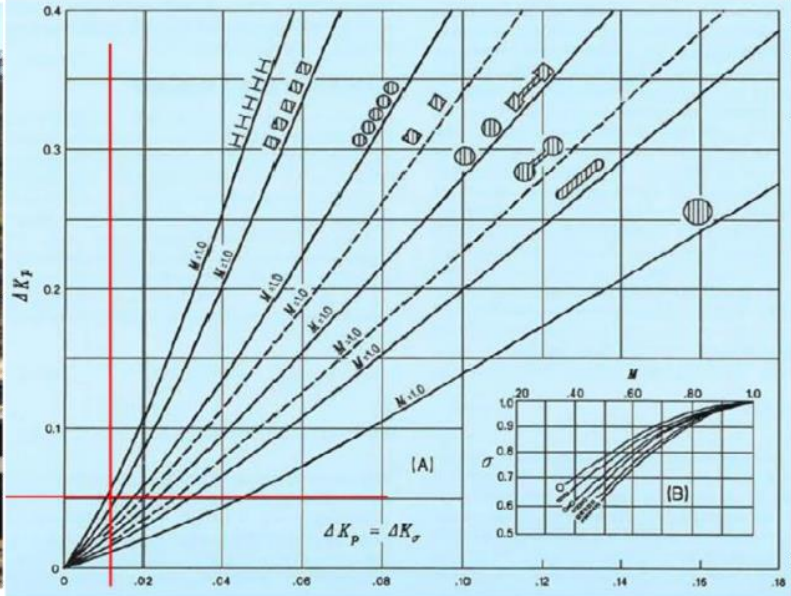
ID	Code	Width (m)	Height (m)	Number	Config	Name	Type	CreekName	Estimated/Measured	Loss	X	Y
85	A85	24	1.9	2	3 x 8	Childcare Centre Pallet Bridge	Bridge	Muttama Creek	Measured	0.05	593475.74	6167068.97
