**COOTAMUNDRA-GUNDAGAI
REGIONAL COUNCIL**

COOTAMUNDRA FLOOD STUDY

FINAL

JANUARY 2021

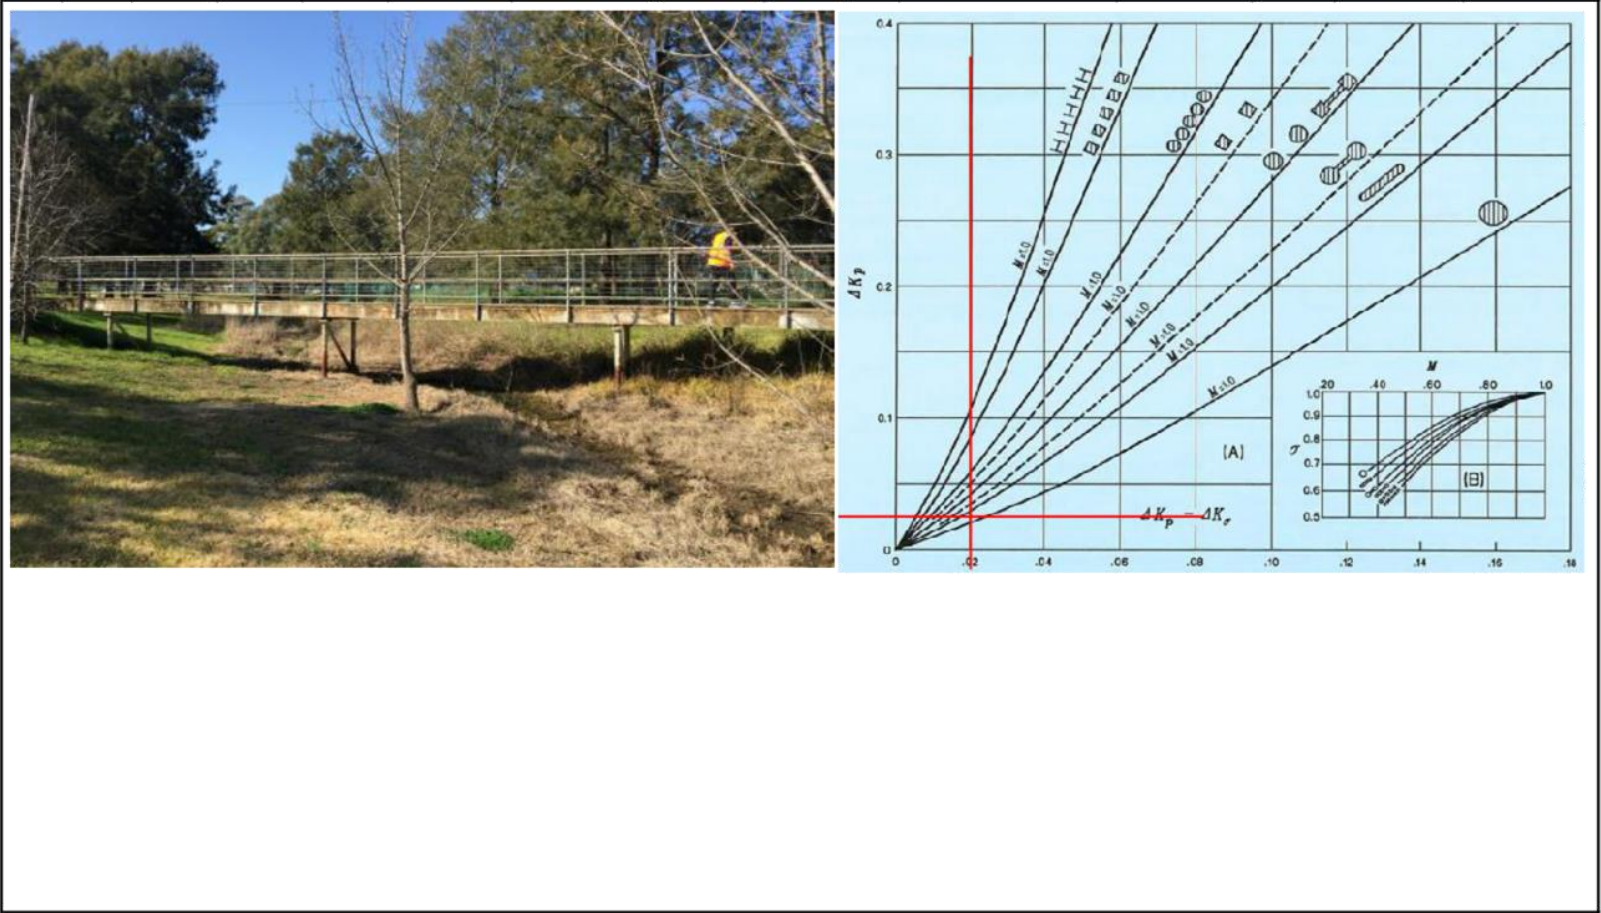
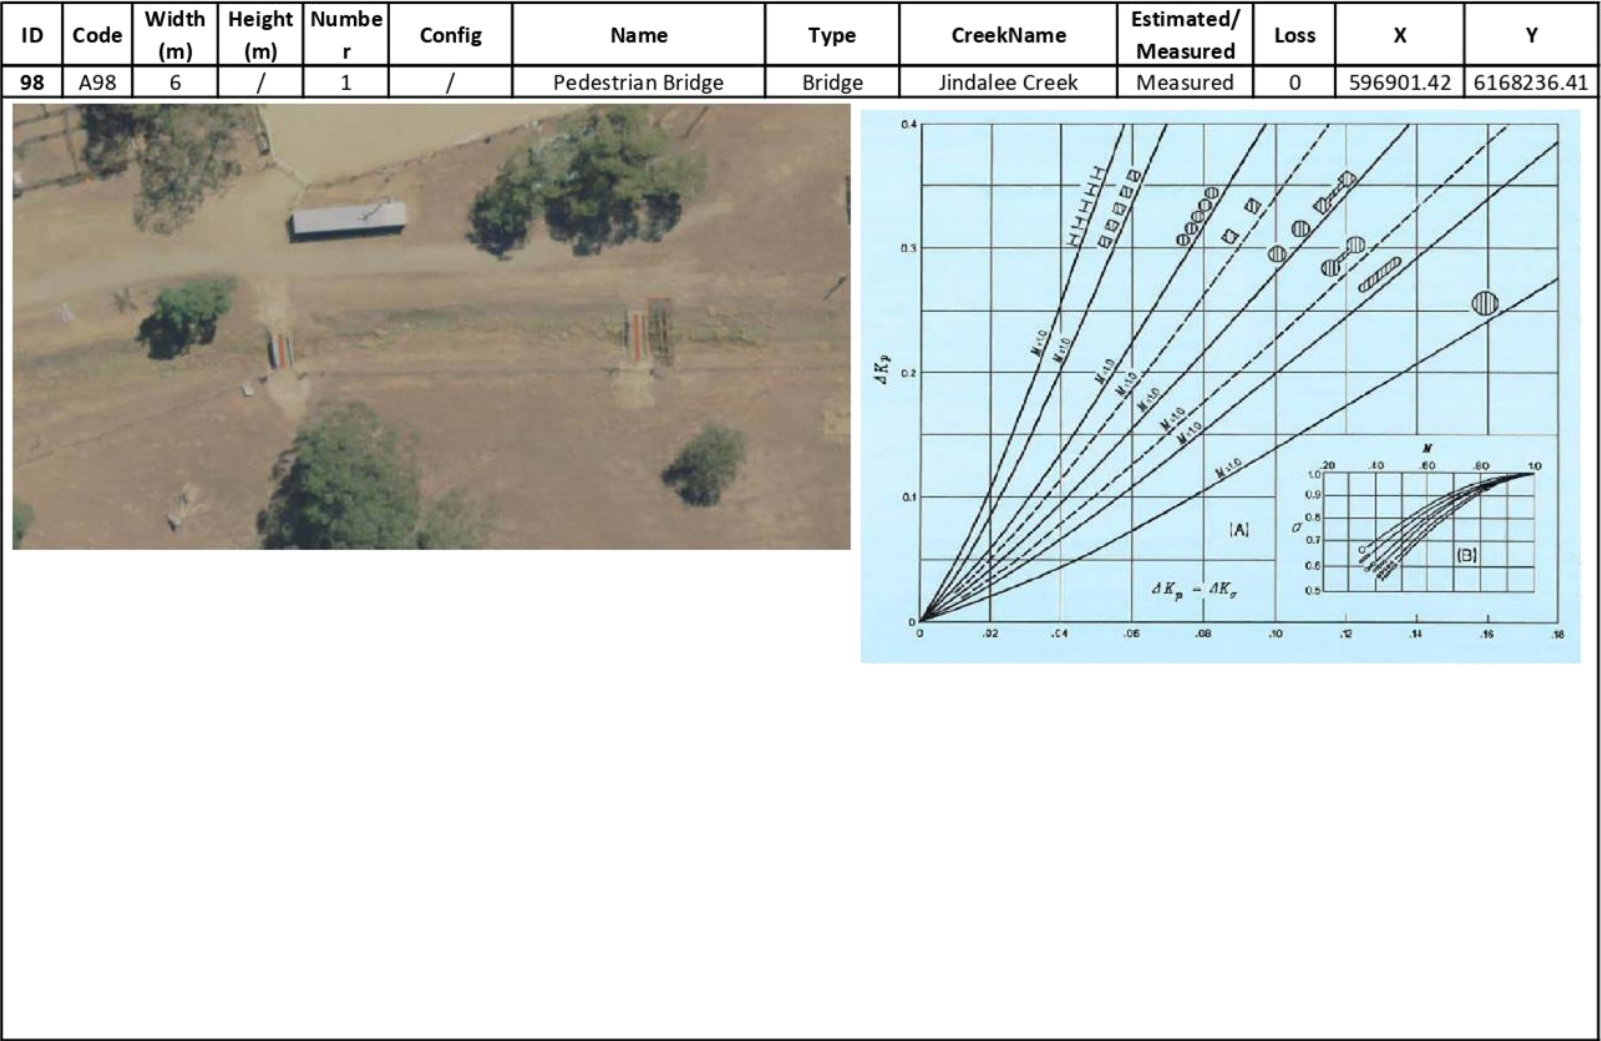
ID	Code	Width (m)	Height (m)	Number	Config	Name	Type	CreekName	Estimated/Measured	Loss	X	Y
88	A88	5.9	1.4	4	4 x 5.9	Olney St Pedestrian Birdge	Pedestrian Bridge	Muttama Creek	Measured	0.05	593609.14	6166906.21

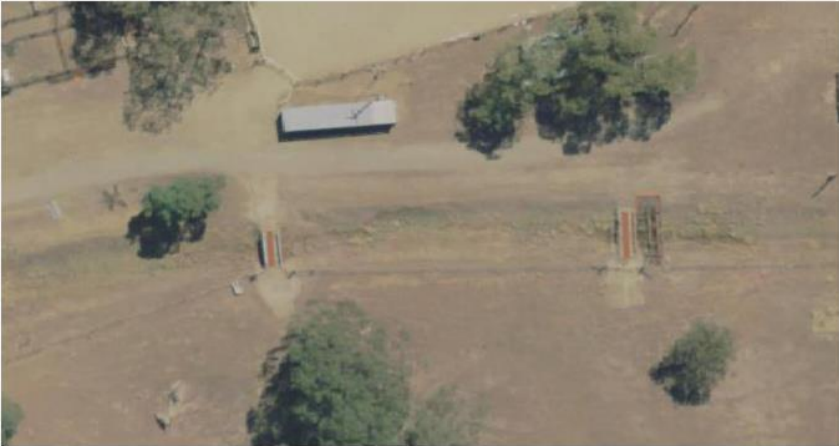
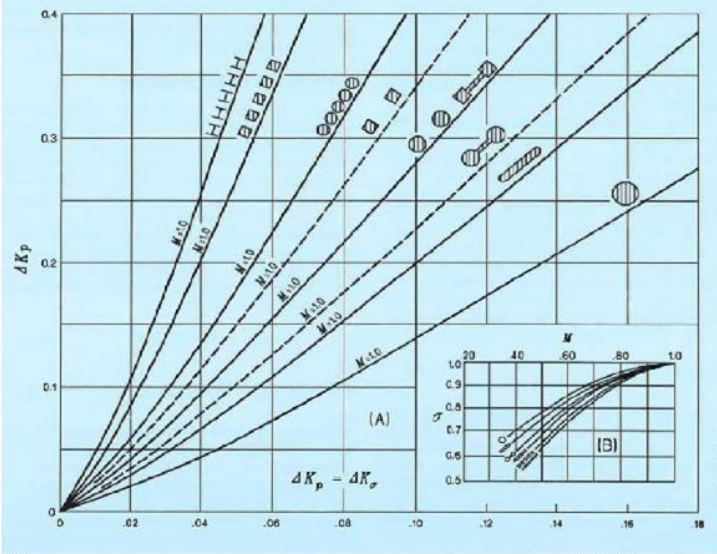
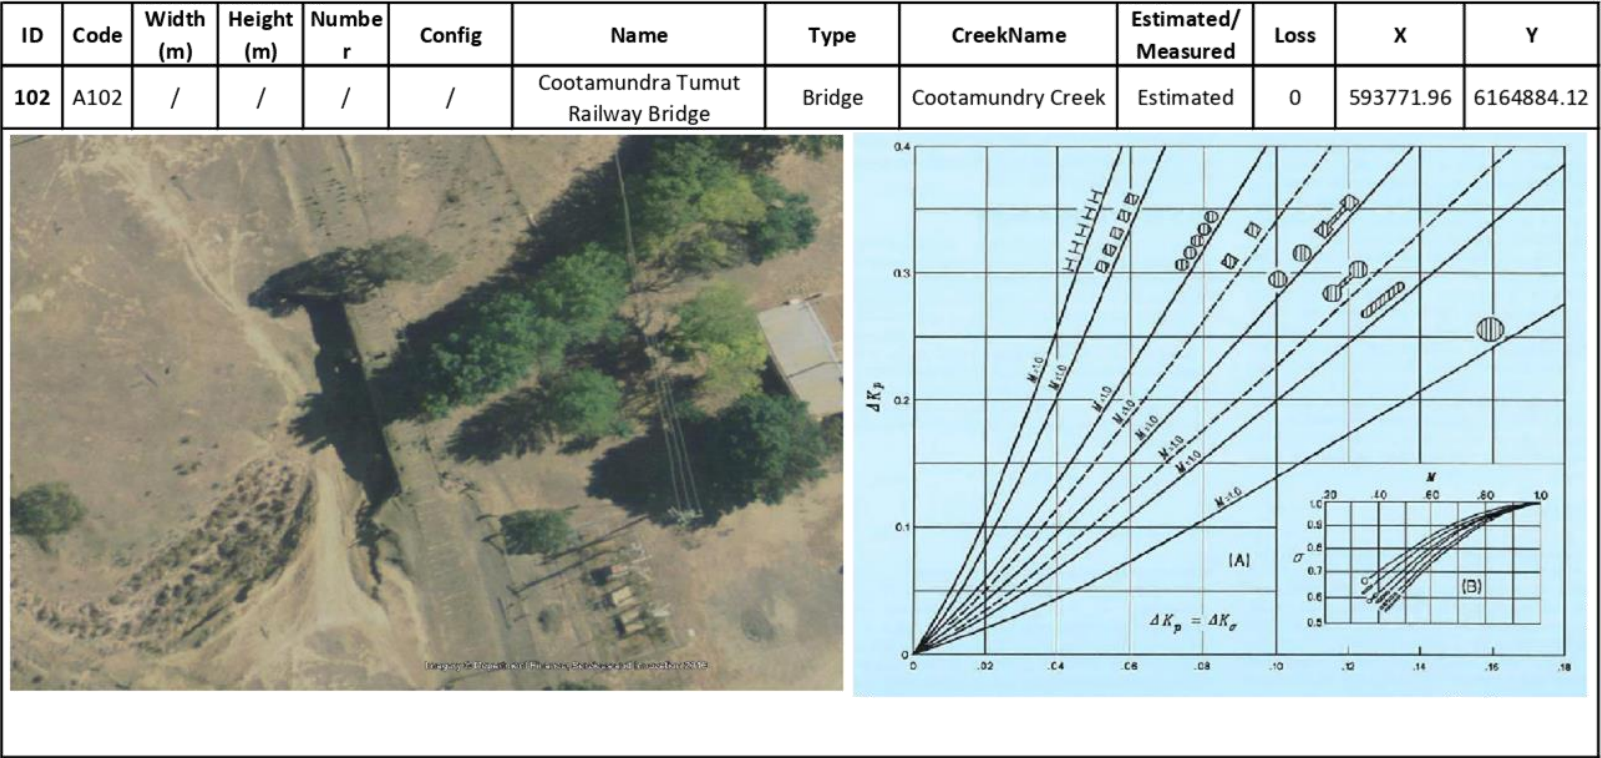
ID	Code	Width (m)	Height (m)	Number	Config	Name	Type	CreekName	Estimated/Measured	Loss	X	Y
98	A98b	4.5	/	1	/	Pedestrian Bridge	Bridge	Jindalee Creek	Estimated	0	596854.12	6168234.41
