# OLD GUNDAGAI GAOL MASTERPLAN REPORT

30 JULY 2018

OLD GUNDAGAI GAOL MASTERPLAN REPORT

### APPENDIX 2 - ARCHAEOLOGY ASSESSMENT REPORT

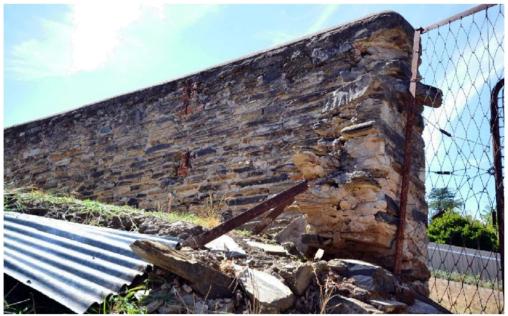
Demolished stone work of the external exercise yards should be reinstated where practicable.

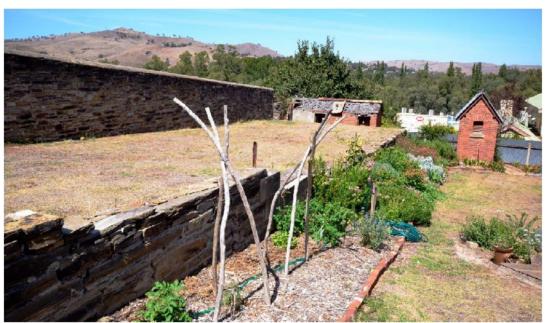
View of the bottom exercise yard, presently filled and landscaped. As far as practicable, this should be reinstated to an exercise yard. The two cubicle toilet should be reroofed.

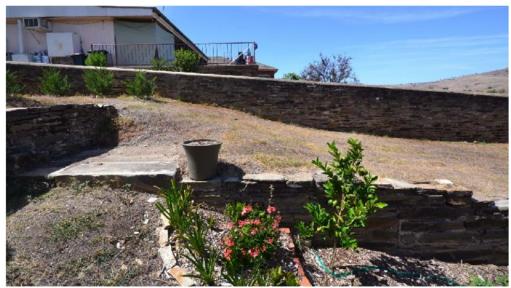
A view of the top exercise yard shows unnecessary fill obscuring the wall outlines of the yard, which should be at least partially reinstated.

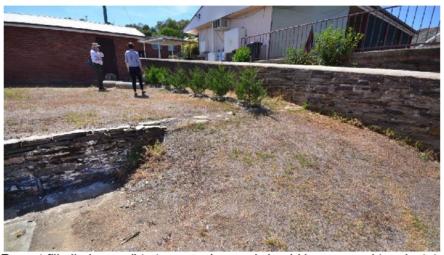
Recent fill piled up wall to top exercise yard should be removed to reinstate approximations of original levels.

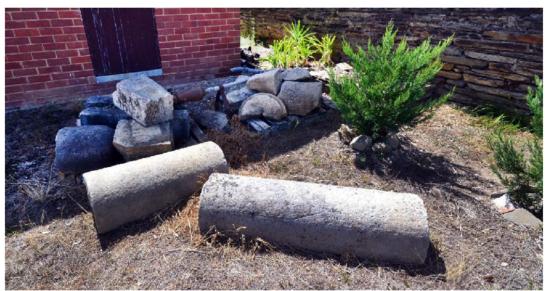
Dumped items of stonework should be reinstate where possible, otherwise left in-situ for future use.

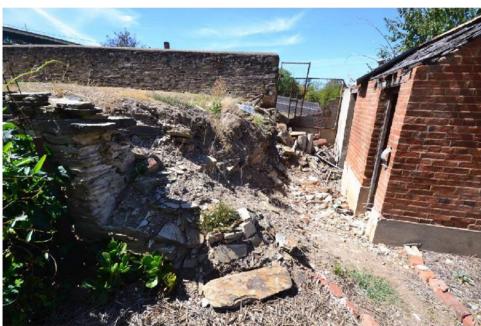
Section of demolished wall that should be reinstated.

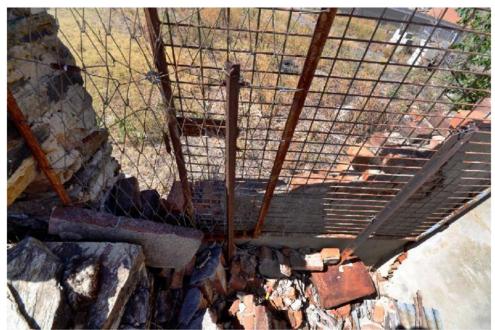
Section of demolished wall that should be reinstated.

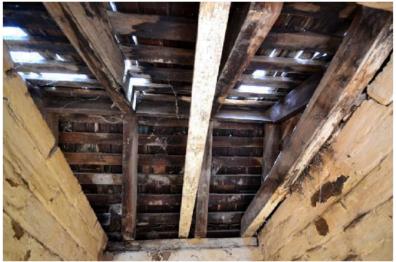
Inside the toilets, visitors will still be able to view the original framing and remnants of the wooden shingles.

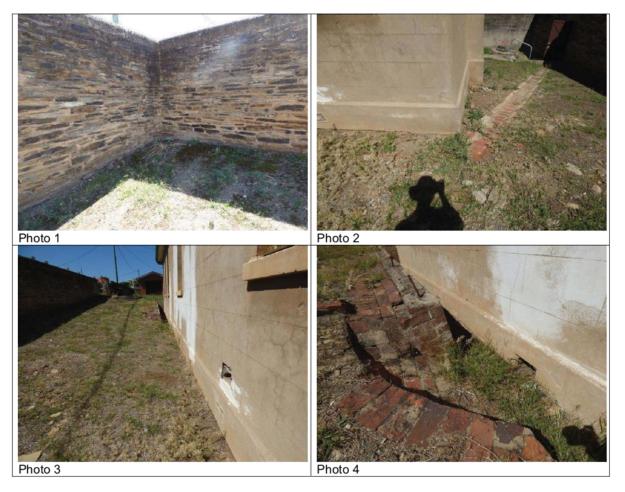
- Starting at the northern corner, see photo 1.
- Land falls to the southeast, towards the hospital, with brick spoon drain, see photo 2.
- Brick spoon drain running along wall and in front of retaining wall, see photo 3.
- Storm water directed from top of retaining wall into existing vent under building, see photo 4.

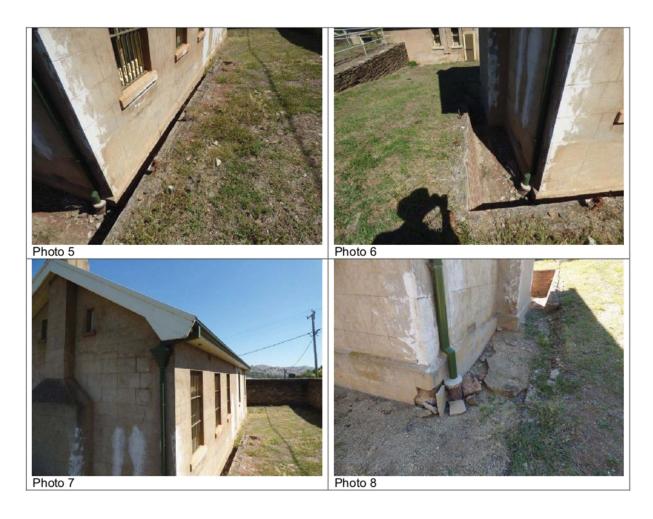
- Brick spoon drain on top of retaining wall, Note: line along wall of hospital that shows where earth was piled up against the building in the past see photo 5.
- Brick spoon drain down short side, see photo 6.
- Northern gutter of hospital, generally looks in good condition see photo 7.
- End of brick spoon drain eastern side of hospital. Erosion to surface levels and water damage to building. Downpipe going into terracotta pipe. see photo 8.

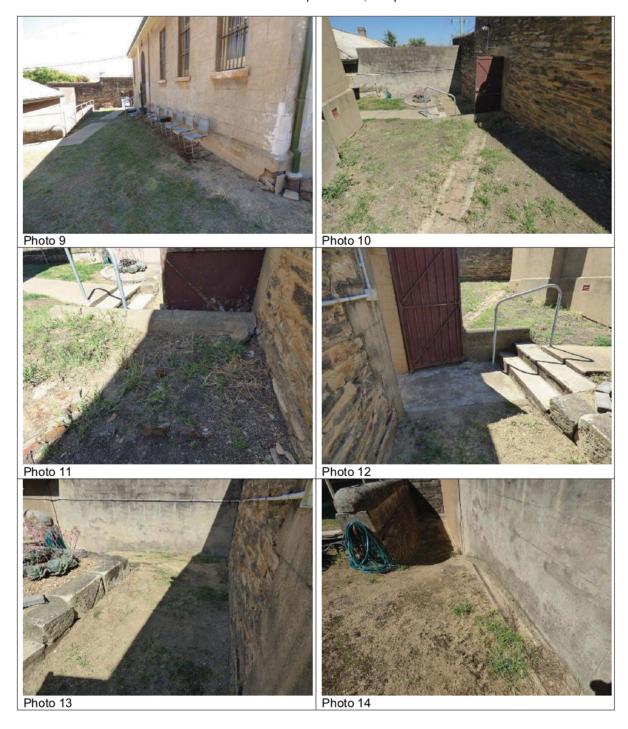
- General view front of hospital, see photo 9.
- Note: the hospital only has two downpipes on the eastern end of the building.
- Brick spoon drain leading to stairs, with no visible drainage see photo 10 and photo 11.
- Small retaining wall and brick spoon drain at entrance stairs, see photo 12.
- Water falls from stairs towards exercise yard wall, see photo 13.
- Water falls into narrow 250 mm wide concrete spoon drain, see photo 14.

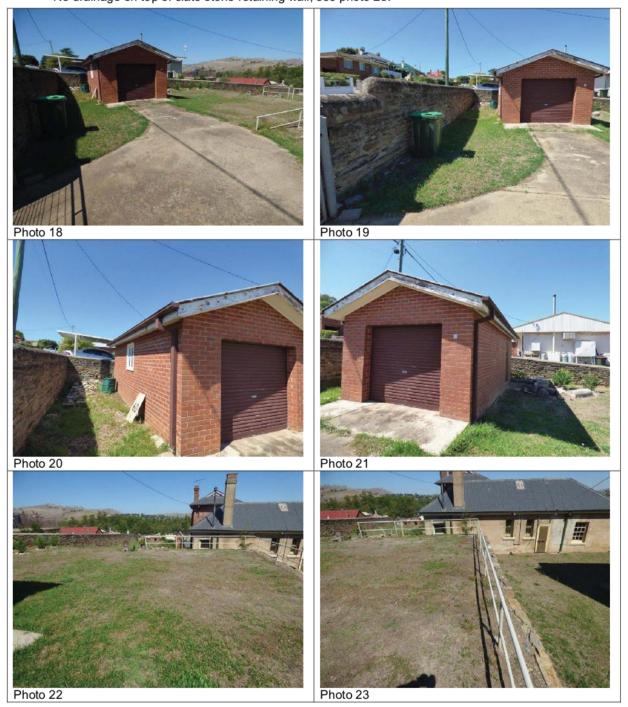
- Existing driveway leading to newer garage building, see photo 18.
- General view into the eastern corner, see photo 19.
- Gutter and downpipe for garage, see photo 20 and photo 21
- exercise yard falls to the south, no visible drainage infrastructure, see photo 22.
- No drainage on top of slate stone retaining wall, see photo 23.

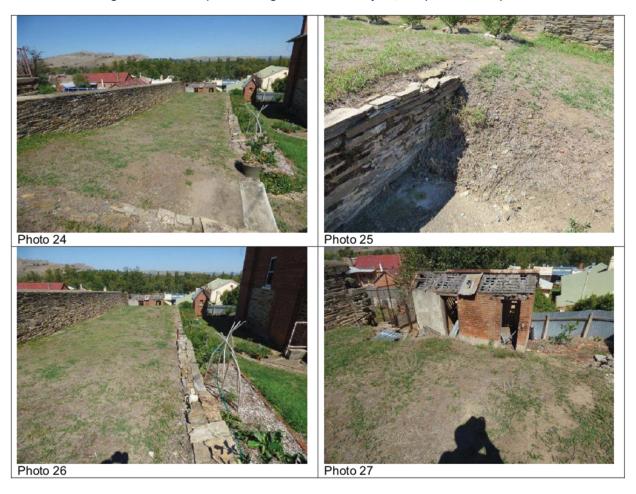
- · Women's yard grassed area falls to the south, see photo 24.
- Earth piled up against retaining wall top of women's yard, see photo 25.
- No drainage structure on top of retaining wall of women's yard, see photo 26 and photo 27.

The drainage in the area does not appear to be causing issues as it is mostly open ground. However, uncontrolled flow over retaining walls is not recommended and improvement should be made to reduce this. Further adjustments should be considered to direct less overland flow in the direction of the kitchen block.

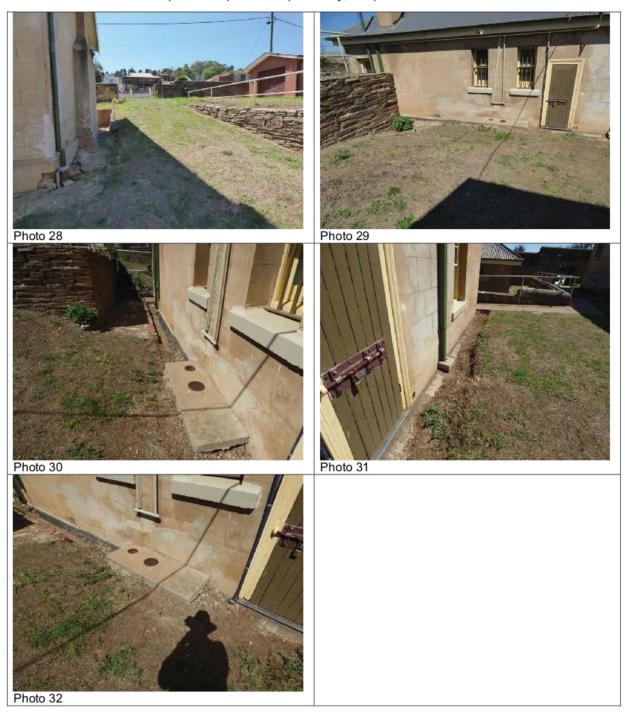
- Water from driveway along street falls towards kitchen block and hospital, see photo 28 and photo 29.
- Drainage at front of kitchen block is an brick spoon drain, see photo 30 and photo 31.
- Sewer concrete slab placed in spoon drain previously, see photo 32.

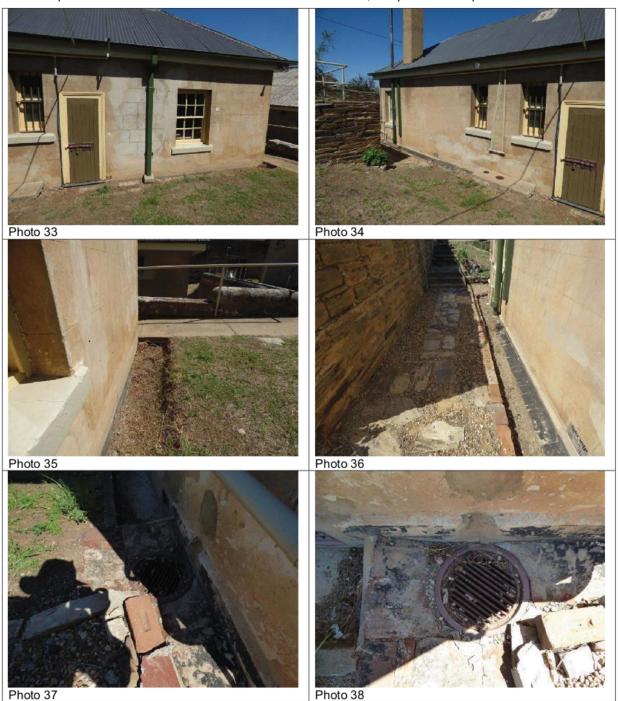
- Gutter and downpipe system for kitchen block, generally in good condition see photo 33 and photo 34.
- Drainage leads under concrete path, see photo 35.
- Newly formed path and brick edging adjacent to spoon drain, see photo 36.
- Open storm water drain leads around to sewer connection, see photo 37 and photo 38.

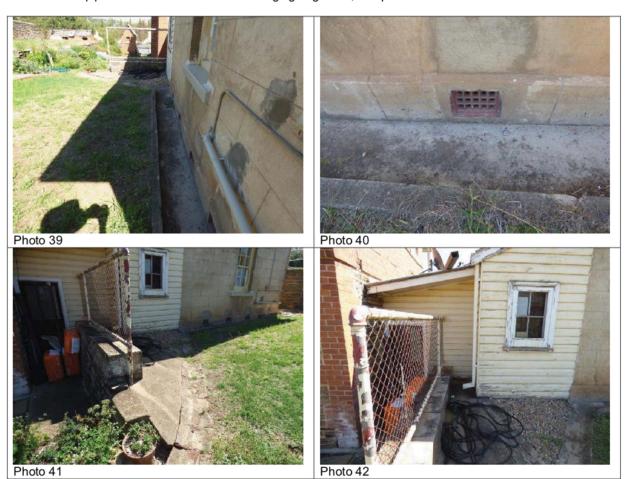
- · Newer concrete spoon drain leads to the south along edge of kitchen block, see photo 39.
- Noting level of vents and drain are close, see photo 40.
- brick spoon drain leads away from kitchen block and around retaining wall, see photo 41.
- Downpipe from timber extension discharging to ground, see photo 42.

The kitchen block will need improved drainage on the northern side as a large portion of over land flow is directed towards it. In addition to this the flow has been blocked by a concrete slab increasing the risk of flooding. The flow moves to the east and is directed towards a grated sewer inspection opening (I/O). The storm should be directed around the I/O and the I/O raised above ground level to prevent storm water contamination. Down pipes should be connected to the proposed new storm water system.

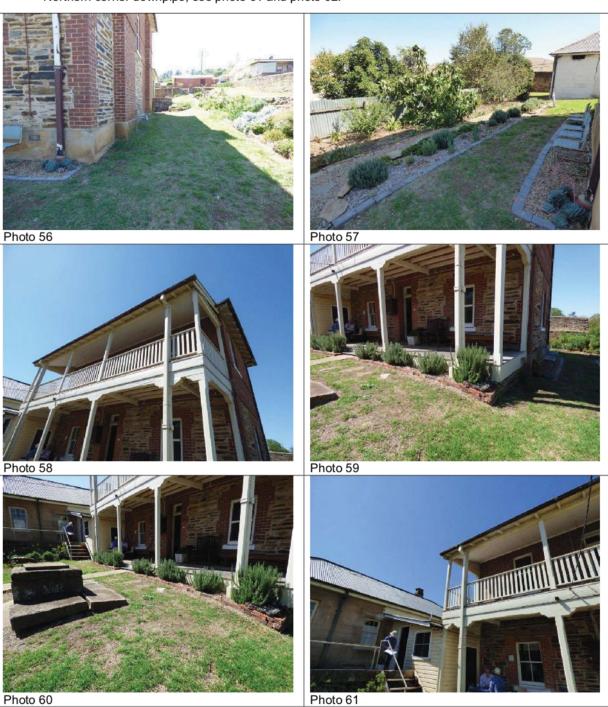
- Drainage on south eastern side of jailer's residence falls away from building, see photo 56.
- Rear of yard of jailer's residence falls away from building, see photo 57.
- Downpipe western corner of jailer's residence, see photo 58 and photo 59.
- Land falls away from verandah of jailer's residence, see photo 60.
- Northern corner downpipe, see photo 61 and photo 62.

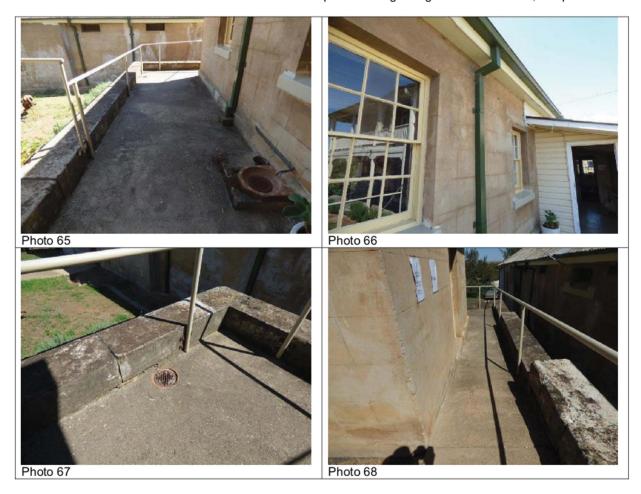
- Landing on southern side of kitchen, see photo 65.
- Landing is generally flat, see downpipe connection on kitchen, see photo 66.
- Terracotta drain in landing is the only drain for landing, see photo 67.
- Northwestern side of kitchen block concrete ramp and landing falling towards the south, see photo 68.

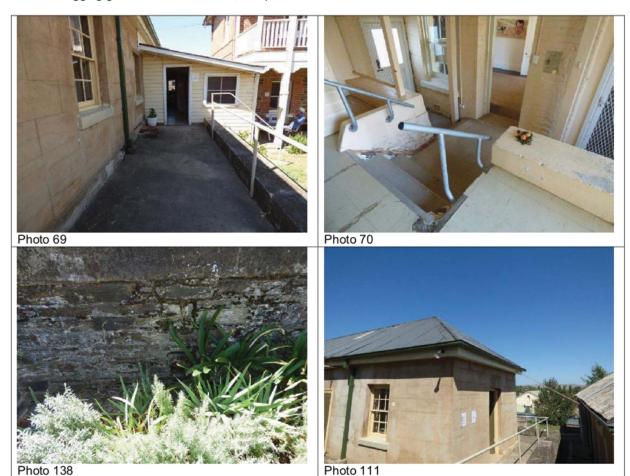
- Drainage falls towards terracotta drain, there is no overland escape path except through the kitchen, see photo 69.
- The over land flow then lead down stairs and into the residence, see photo 70.
- Outlet for small drain in landing above, see photo 138
- Sagging gutters on kitchen block, see photo 111.

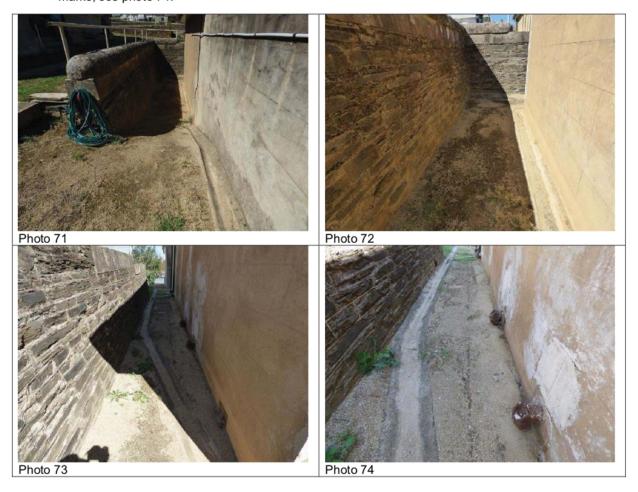
- At northern side of exercise yard, see drainage leading towards the east through concrete spoon drain, see photo 71.
- Surface falls away from retaining wall, see photo 72.
- Concrete drain is silted up. Drain moves away building and sewer connections, see photo 73.
- Noting retaining wall between jail and kitchen and evidence in sand of gutter over flow by the drip marks, see photo 74.

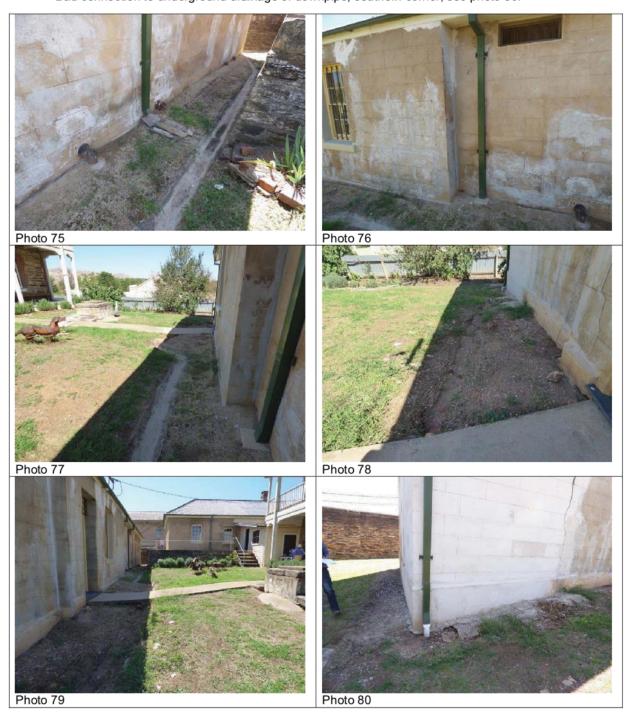
- Downpipe from jail discharging to surface, see photo 75.
- Downpipe discharging to underground sewer system, see photo 76.
- Concrete spoon drain leads to brick spoon drain and under path, see photo 77.
- Erosion from recent storm events other side of path, see photo 78,.
- Land falls away from residence towards jail and leads into spoon drain, see photo 79.
- Bad connection to underground drainage of downpipe, southern corner, see photo 80.

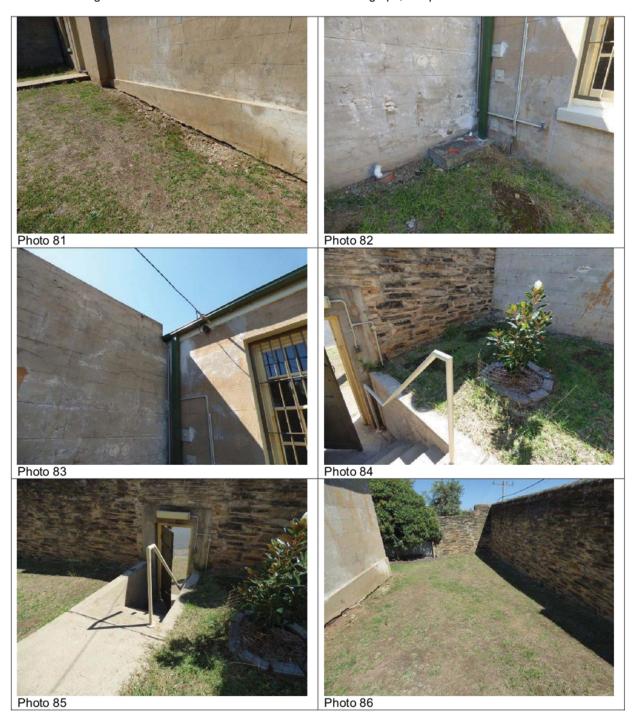
- Erosion along western side of jail, see photo 81.
- Downpipe leading terracotta connection western side of jail, see photo 82 and 83.
- See drainage leading away from exercise yard wall towards second stair entrance, see photo 84 and photo 85.
- Drainage leads down into corner where there is no drainage pit, see photo 86.

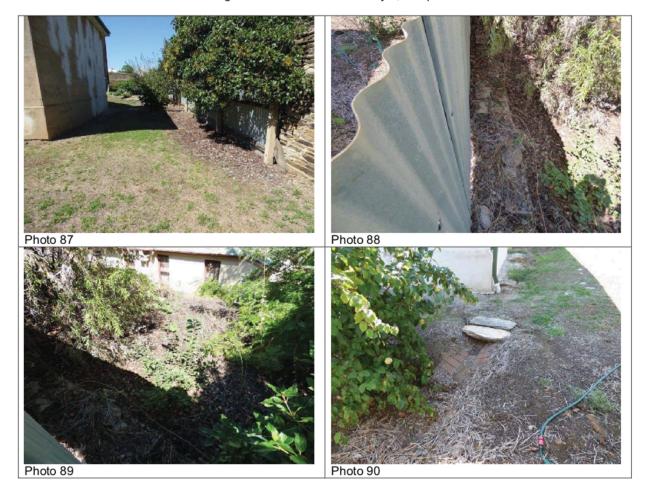
- Drainage along rear of site leads to fence, see photo 87.
- There seems to be no formalised drainage after this, plan notes outlet on top of existing retaining wall, which the fence runs along, see photo 88. this wall is on the court house side of the fence, see photo 89
- Outlet to overland flow drainage on the southern corner of jail, see photo 90.

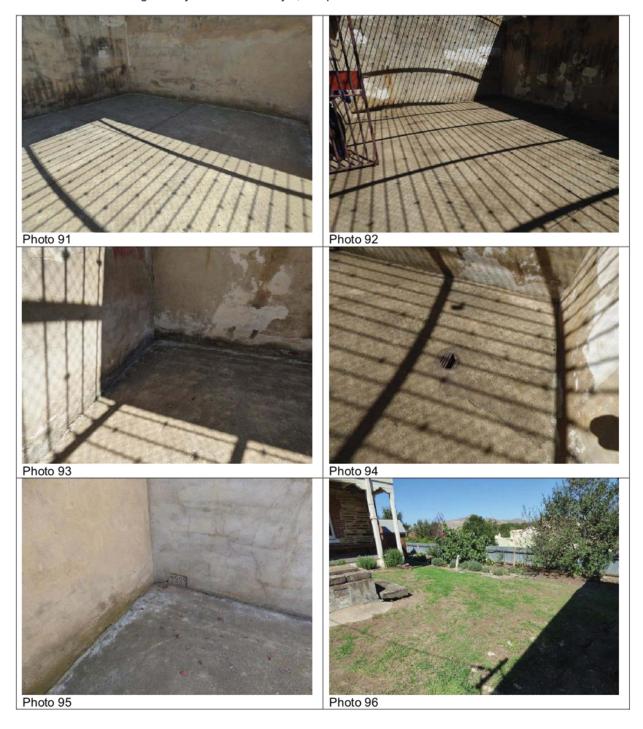
- North side of exercised yard no formal drainage see photo 91 and photo 92.
- Low point in western corner, see photo 93.
- Small circular pit with terracotta pipe on the south eastern corner, see photo 94 noting that if this grate were to block flow would lead into the jail. Should be replaced with new larger grated pit.
- Vent at ground level northeastern corner, see photo 95.
- Surface leading to the jailers house and jail, see photo 96.

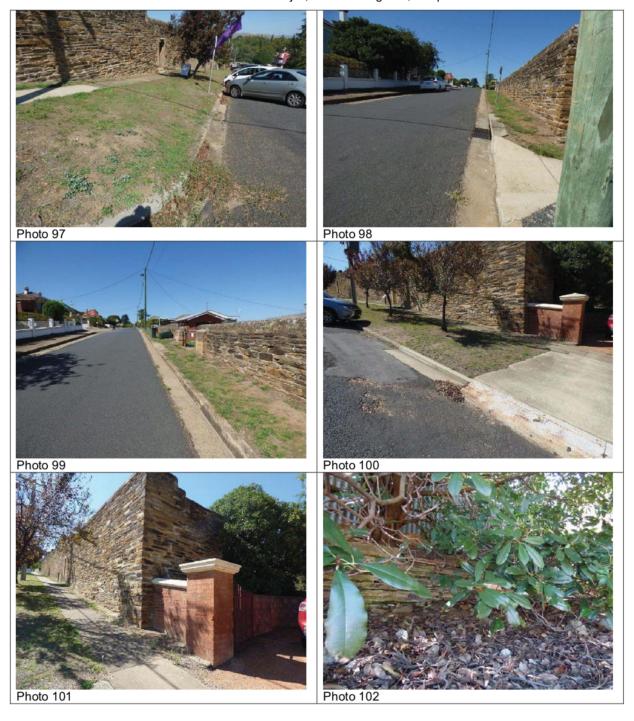
- Byron Street side drainage generally falls away from wall and into the curb and gutter systems, see photo 97.
- First avenue, kurb and gutter provided cut off for upstream drainage, see photo 98 and photo 99.
- There appears to be no pit and pipe drainage system along Byron Street immediately adjacent to jail, see photo 100.
- Western corner, external view, see photo 101.
- Over land flow leads towards rear fence of jail, and retaining wall, see photo 102.

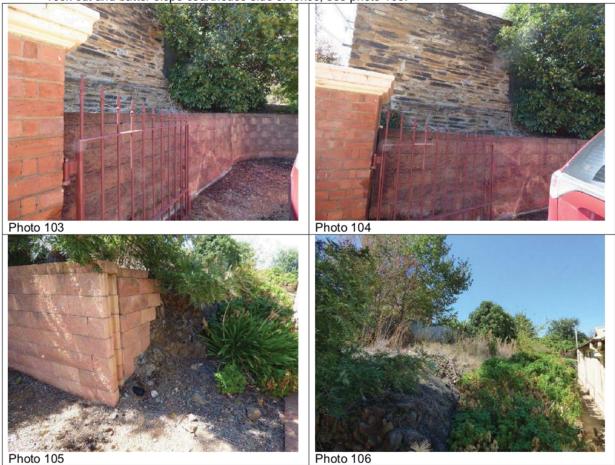
- Newer retaining wall on courthouse side, see photo 103.
- retaining wall and new retaining wall connection and sub soil drain draining to surface, see photo 103, 104 and 105.

rock cut and batter slope courthouse side of fence, see photo 106.

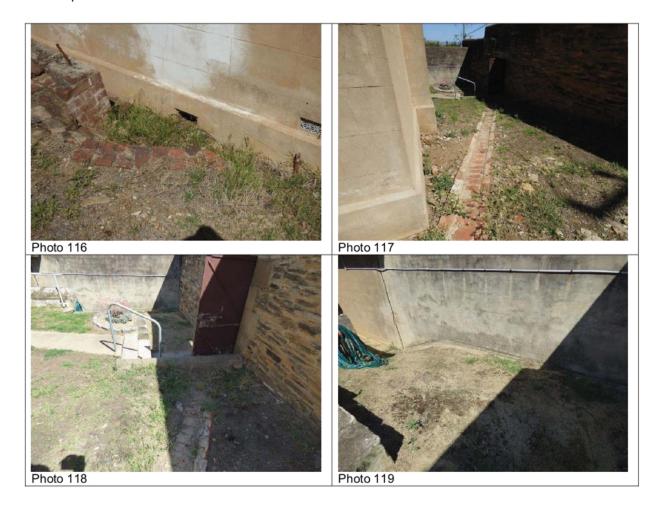
- Undemeath the hospital at one point, see photo 116.
- Flow on the western side move down towards the main pedestrian entrance see photo 117.
- From there it sits in a low point and would overflow over the retaining wall, see photo 118.
- Over land flow falls towards the second exercise yard and into a narrow concrete spoon drain, see photo 119.

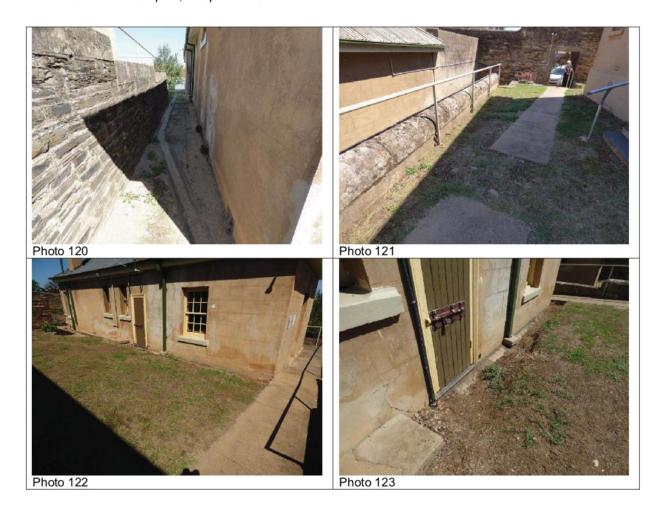
- The water travels down along the spoon drain eventually making it's way along the eastern side of the jail in the spoon drain, underneath the path and towards the rear of the yard, see photo 120.
- Flow immediately in front of the hospital and overflow from the gutters would lead to the top of a retaining wall which is generally flat and would hold water, see photo 121.
- The water then makes it's way along a footpath towards the kitchen, and into the spoon drain, see photo 122.
- The water will flow to the east, gets blocked, and the only over land flow route is either into the building or over the footpath, see photo 123.

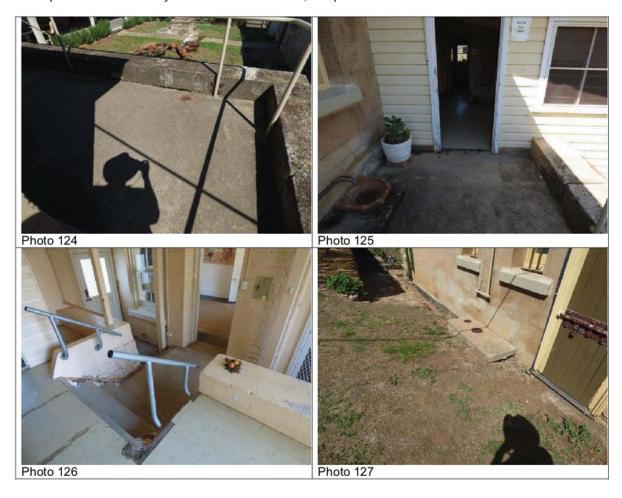
- The water will travel into the kitchen, or if it makes it over the path, travels down to a path toward a terracotta circular pit, see photo 124
- If this pit was blocked or unable to take the flow, the flow would lead into the timber extension, see photo 125.
- Then down the stairs and into the residence This area was once an external area, see photo 126.
- Spoon drain blocked by the newer concrete slab, see photo 127.

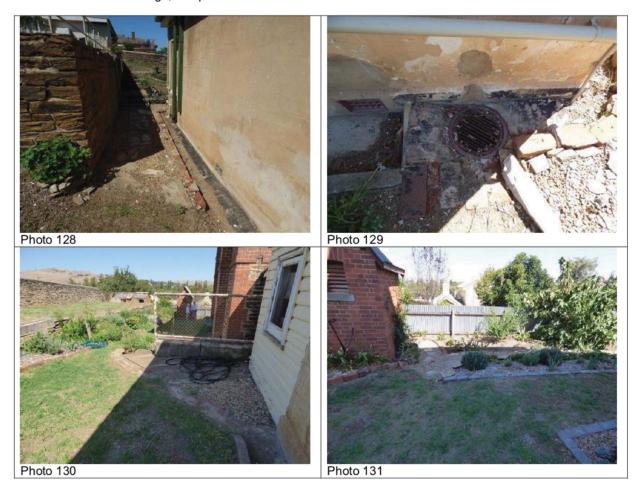
- The flow heads toward the east in a brick spoon drain, see photo 128.
- Water runs down the spoon drain, along the edge of the building, over an sewer connection, see photo 129.
- And then away from the retaining wall and down the eastern side of the jailer's residence, see photo 130.
- This water then travels over grass, and down towards the south towards the fence where there is no formalised drainage, see photo 131.

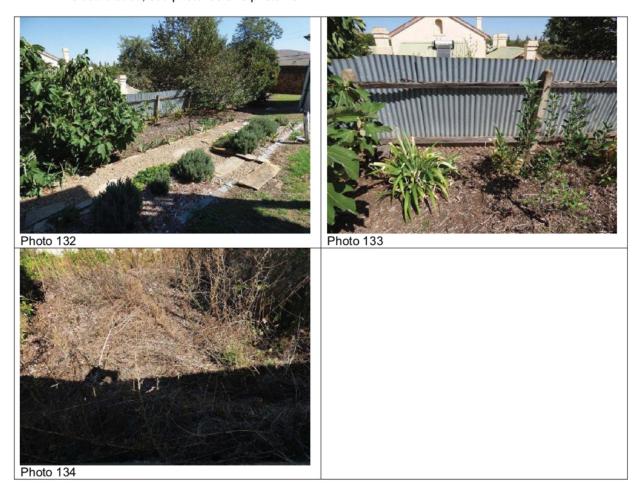
- The overland flow is not formalised along the rear of the property. There is a low point at the very bottom of the jailer's residence, see photo 132.
- The water will sit here and probably seep under the fence though the garden and then down towards the courthouse, see photo133 and photo 134.

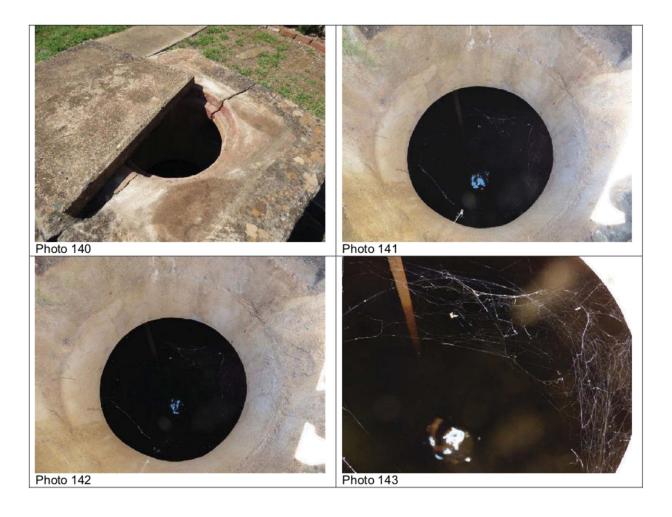
The existing tank in the centre of yard see photo 140-143 some formalized pipe drainage for the site drains to this tank. The tank still holds water and is approximate 6 m deep

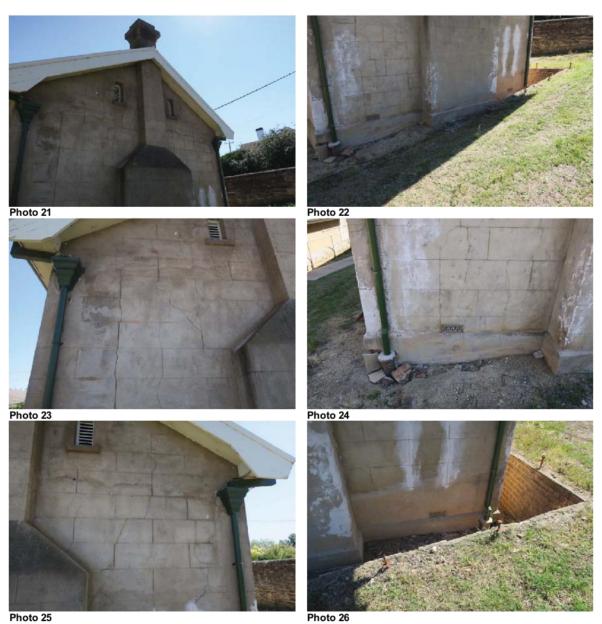
- General view see Photos 21 and 22.
- Crack at south end see Photo 23.
- And below at same location see Photo 24.
- Cracking north end see Photo 25.
- And below same location see Photo 26.

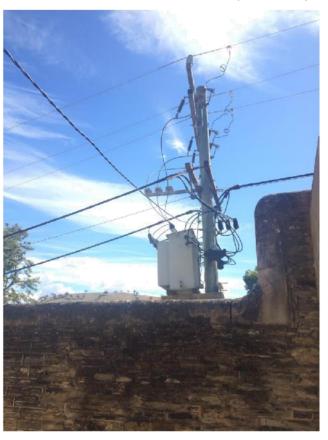
Figure 1-Incoming Electrical Supply to the Cell Block from Byron St

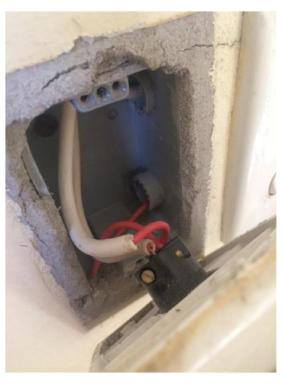
Figure 7 - Cell Block Wall Construction and Typical State of Newer Wiring

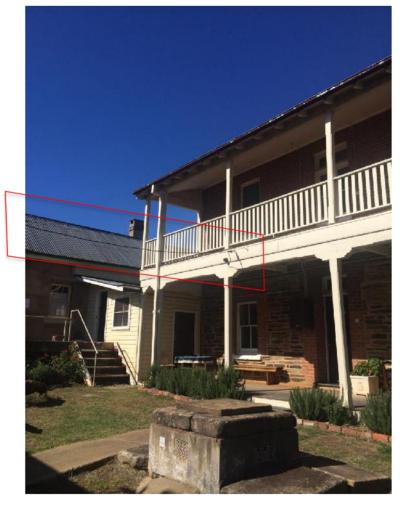
${\it Figure\, 10-Electrical\, Supply\, to\, Gaolers\, Residence}$

Item	Comments
Switchboard Location	Western Wall of Gaolers Residence
Switchboard Fed From	Aerial 1 $\Theta$ supply direct from Cell Block and/or First Avenue as shown in Figure 10, Figure 20 and Figure 21. Appears as 1 $\Theta$ 10-16mm <sup>2</sup> copper aerial supply in both cases.
Switchboard Physical Capacity	Has no remaining physical capacity but can be easily extended.
Switchboard Electrical Capacity	Appears to contain some electrical capacity because the demand is not likely as high as the main switch rating. Where the electrical supply is indeed from the Cell Block the limitation will be the supply from the Cell Block main switchboard.
Switchboard Contain Residual Current Devices	Yes
Switchboard Ability to Support RCDs (Yes/No)	Yes, but not more than what is already installed.
Switchboard Mounted on Asbestos	Yes
Switchboard Generally Compliance	Compliant to the regulations of the day, not compliant to regulations of today.

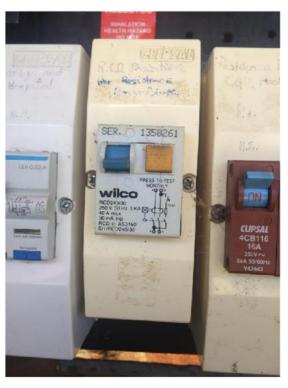
Figure 13 - RCD addition to a portion of new wiring

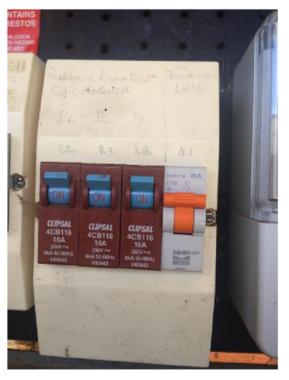
Figure 14 - New sub board installation within main switchboard

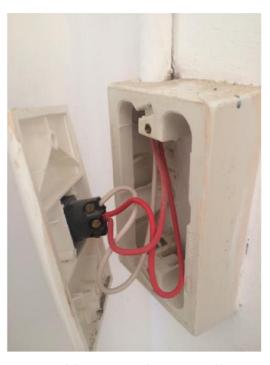
$\textit{Figure 19-Solid copper wiring of newer wiring addition to Gaolers \textit{Residence}}$

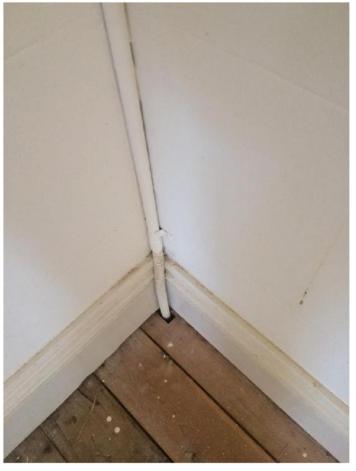
Figure 32-Infirmary Block Recent Electrical Installation (Penetration through floor)

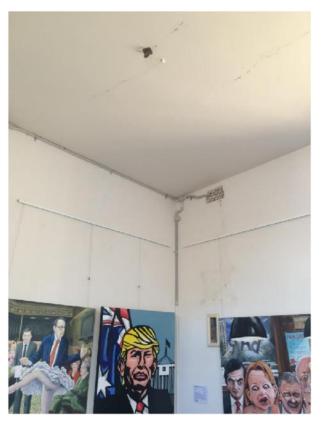
Figure 33-Infirmary Block Recent Electrical Installation (Entrance into building through vent)

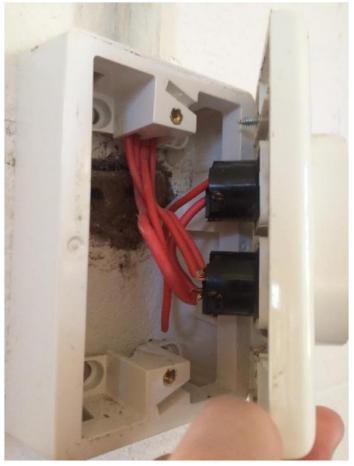
Figure 34 - Infirmary Block Recent Electrical Installation
